## A- Select Services

Property: Any Street  
Crosby, TX 77532

Price List: TXHO5B\_MAY09  
Restoration/Service/Remodel  
Estimate: SAMPLETAX1

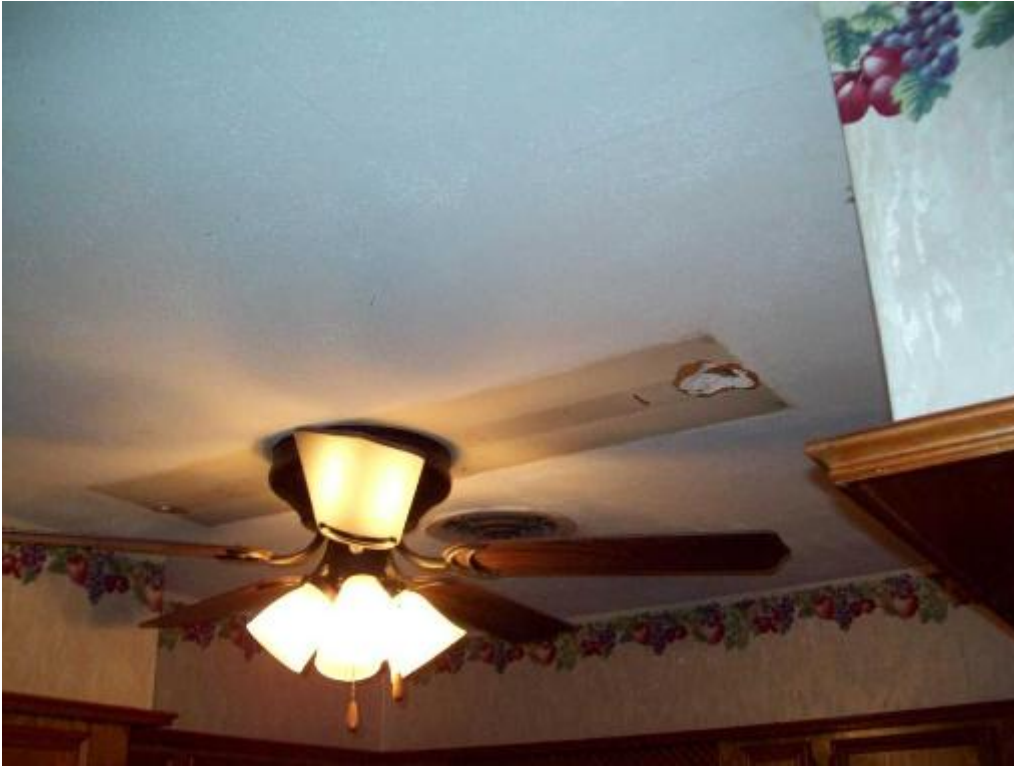
1 Kitchen 7/18/2009  
Taken By: Butch Bragg  
Ceiling damage in kitchen

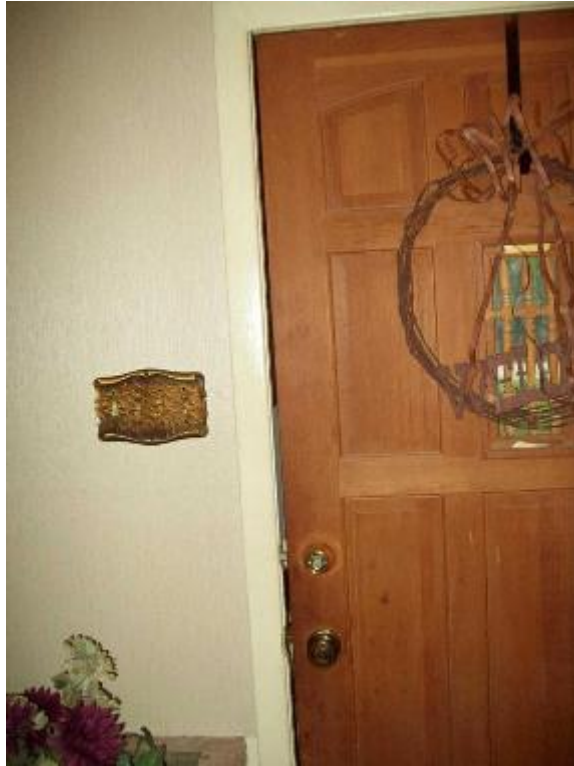
2 Front door

Door has shifted from house settlement and there is about a 3/4 inch crack on the opening side -- door cannot be adjusted.

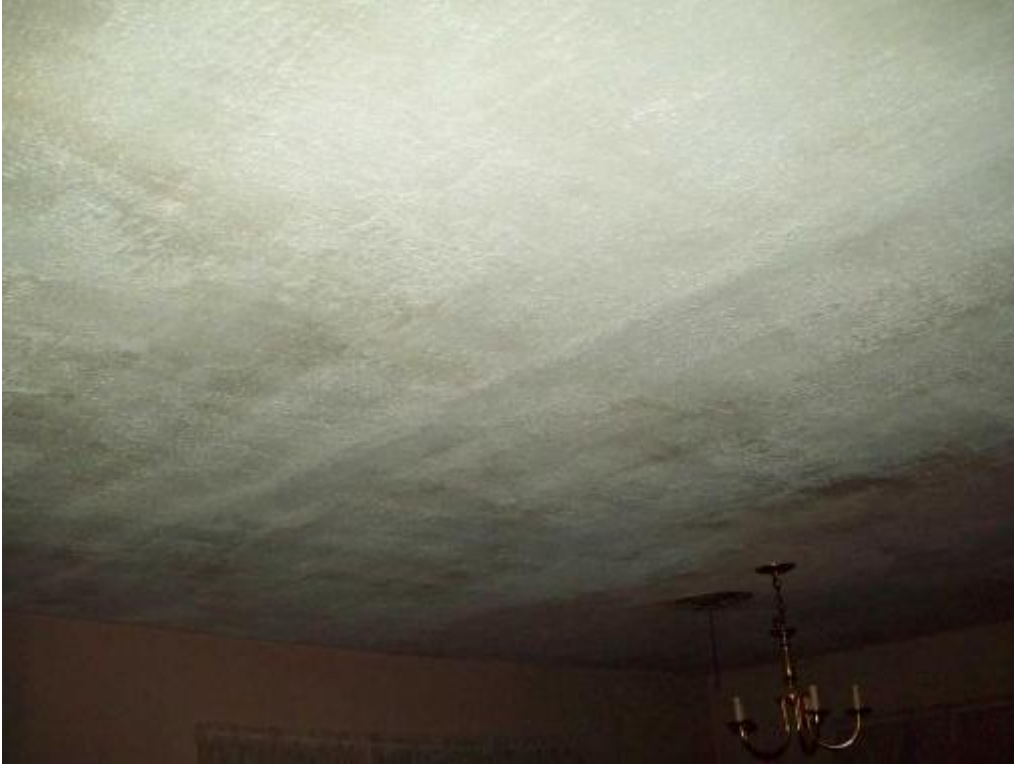
- 3 Dining room 7/18/2009  
Taken By: Butch Bragg  
Sag and split in ceiling from settlement.

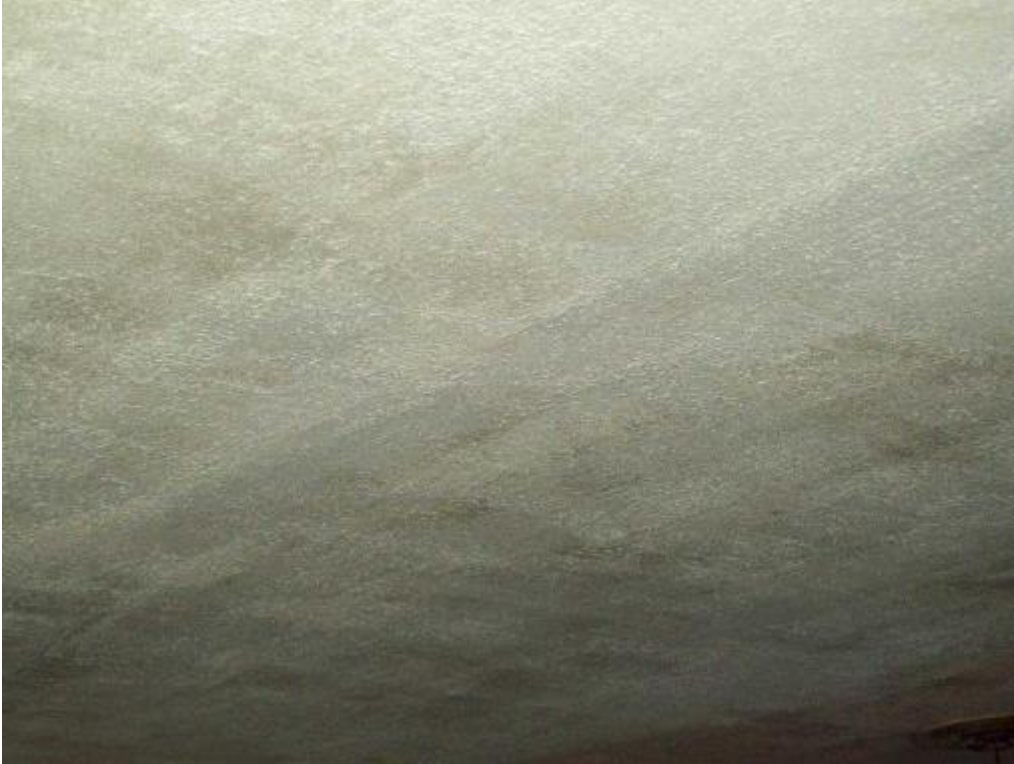
4 Dining room 7/18/2009  
Taken By: Butch Bragg  
Additional photo of settlement

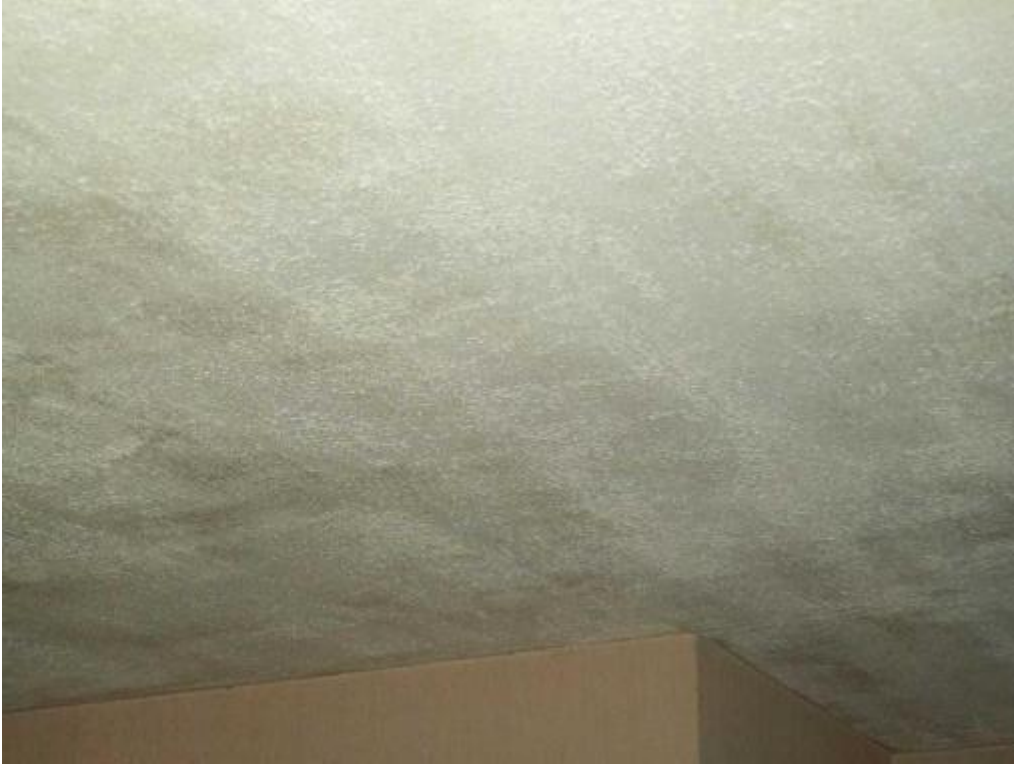
5      Entry                      7/18/2009  
         Taken By:      Butch Bragg  
                                 Sagging ceiling between dining room and entryway

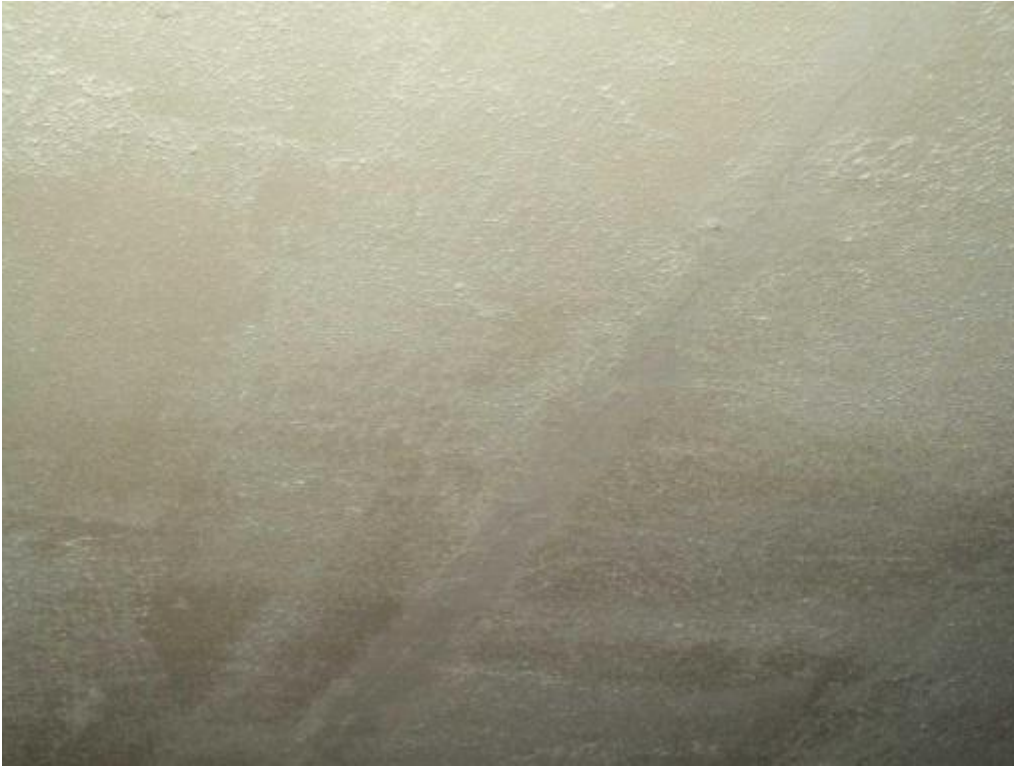
6 Living room 7/18/2009  
Taken By: Butch Bragg  
Sagging/split seam in living room form settlement

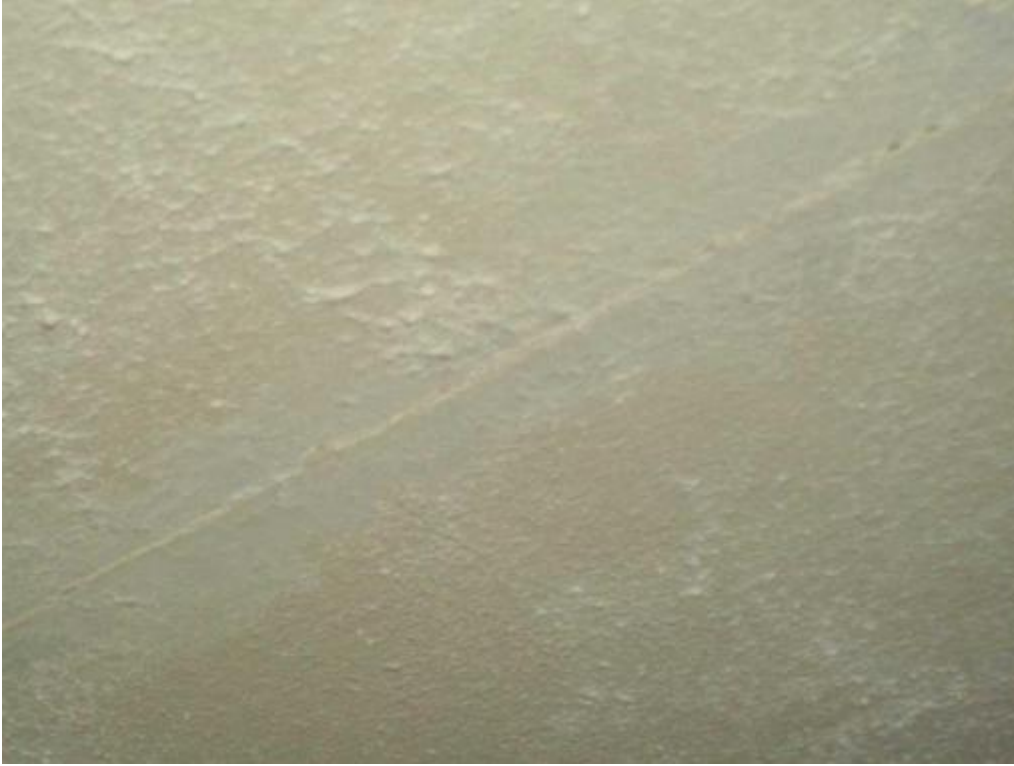
7 Living room 7/18/2009  
Taken By: Butch Bragg  
Better photo of ceiling in living room

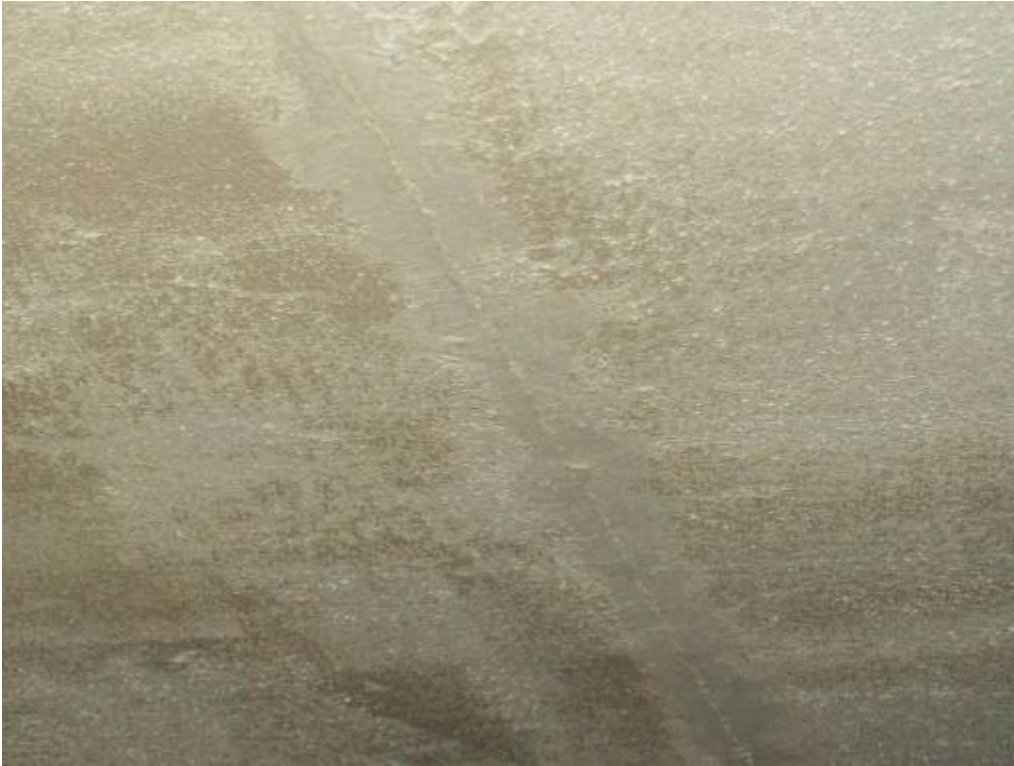
8 Living room 7/18/2009  
Taken By: Butch Bragg  
Ceiling sagging and separating in living room

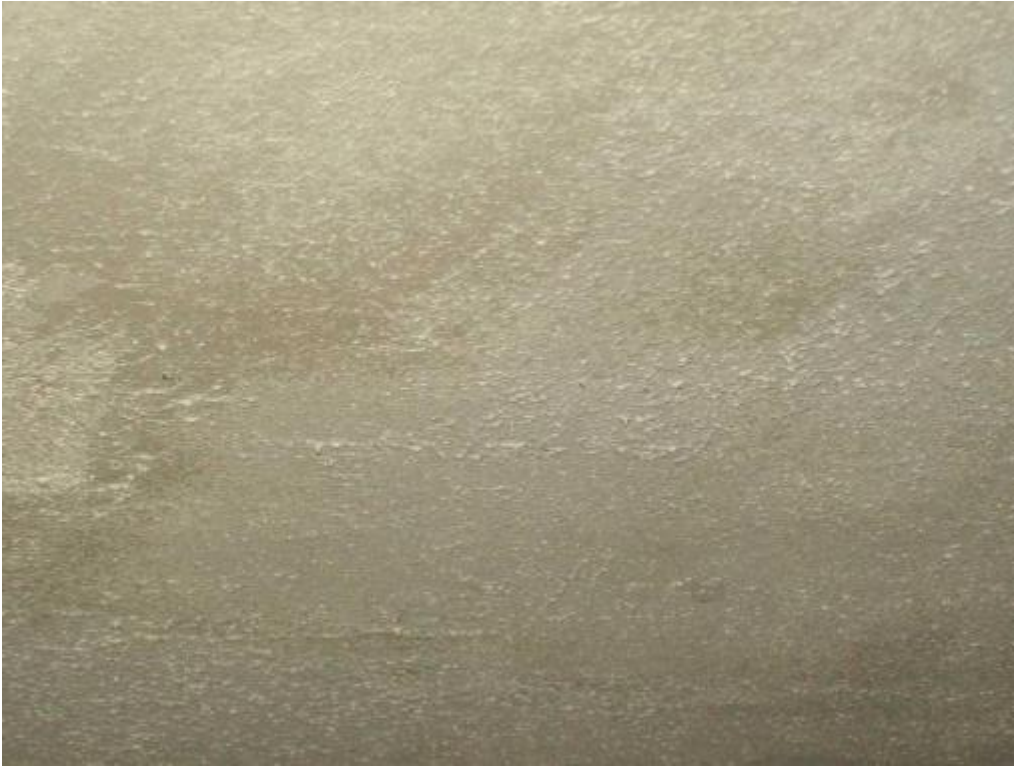
9 Living room 7/18/2009  
Taken By: Butch Bragg  
Area attaching to split/sagging ceiling

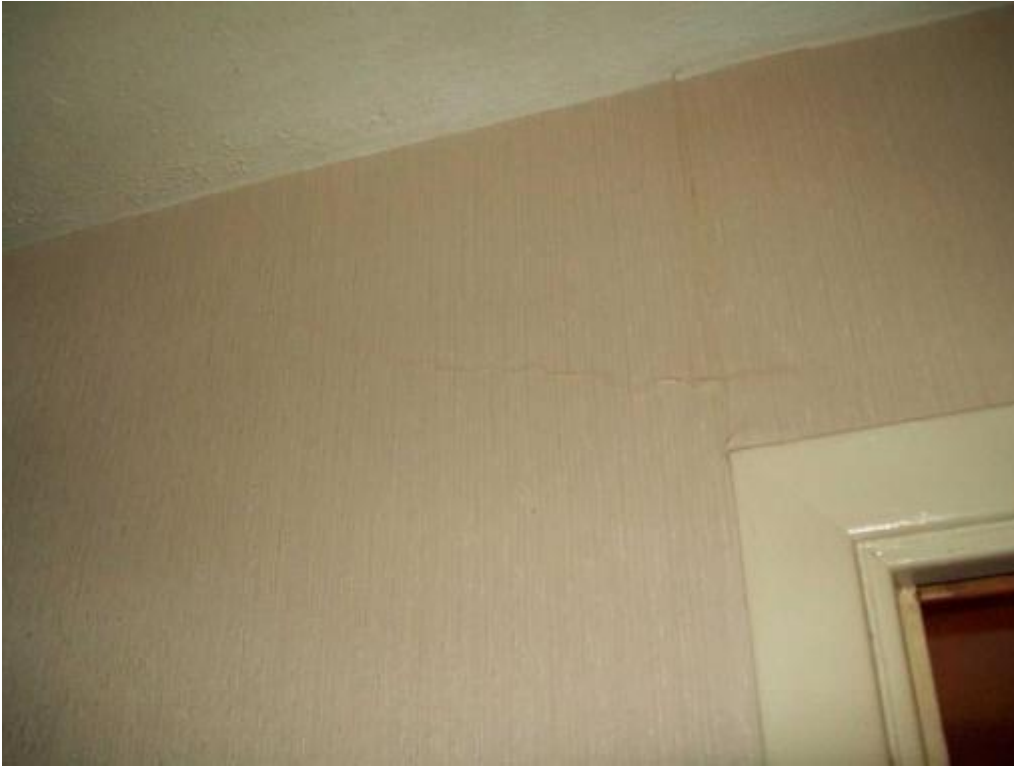
10 Dining room 7/18/2009  
Taken By: Butch Bragg  
Settlement crack at doorway to kitchen splitting vinyl wallpaper  
and damaging drywall

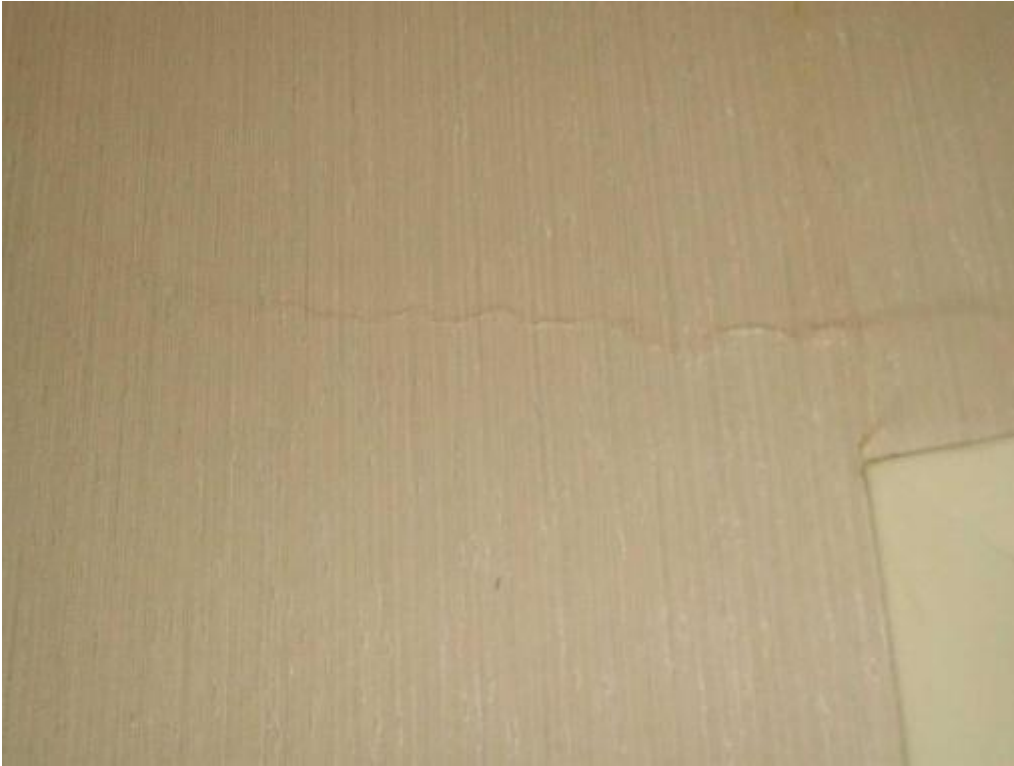
- 11 Dining room 7/18/2009  
Taken By: Butch Bragg  
Better photo of length of crack and damage caused form  
settlement.

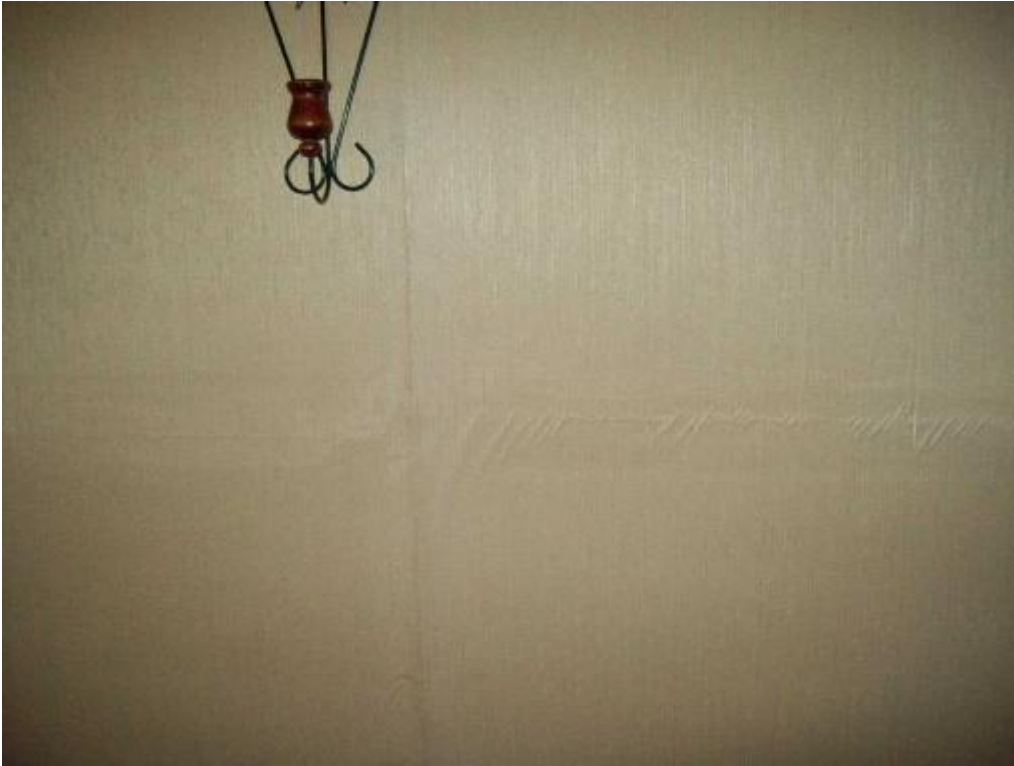
- 12 Living room 7/18/2009  
Taken By: Butch Bragg  
One of the cracks from settlement in wall(s) damaging sheetrock and vinyl wallpaper.

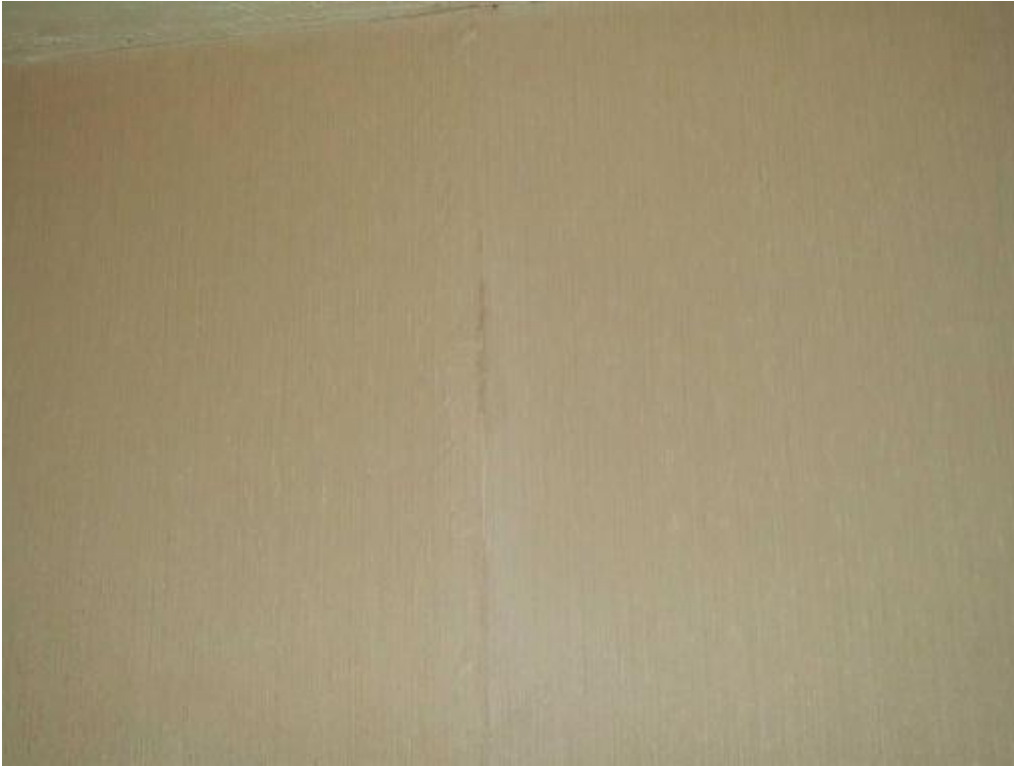
13 Living room 7/18/2009  
Taken By: Butch Bragg  
Additional wall damage

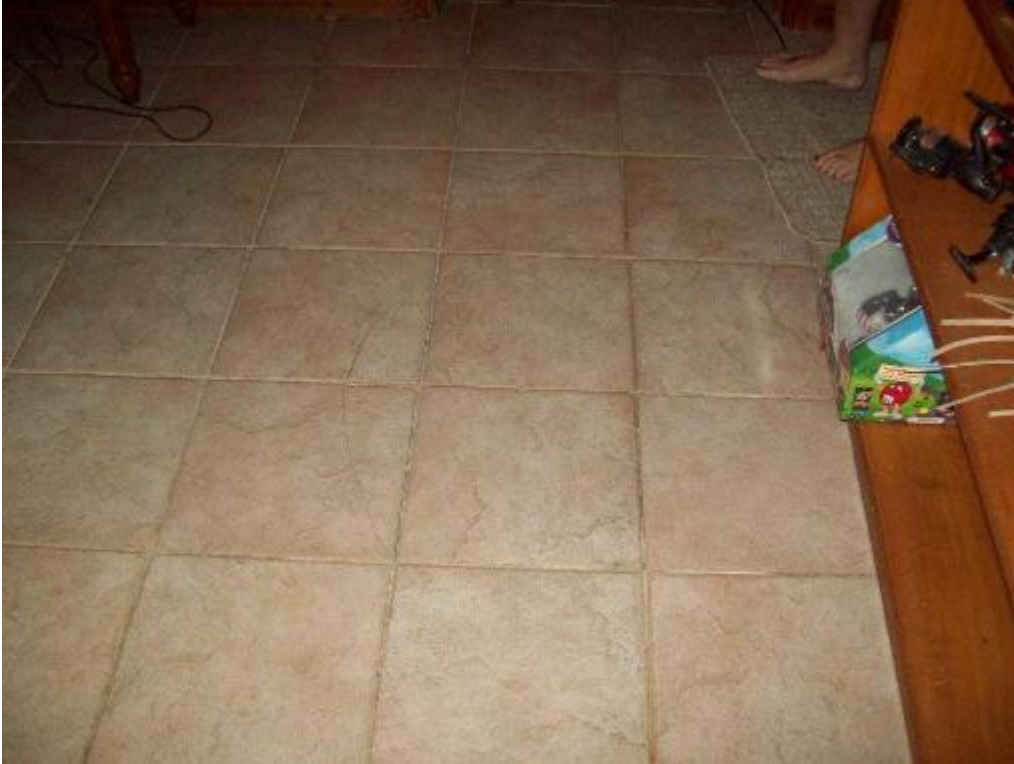
15 Den 7/18/2009  
Taken By: Butch Bragg  
Cracked tile and missing grout from settlement

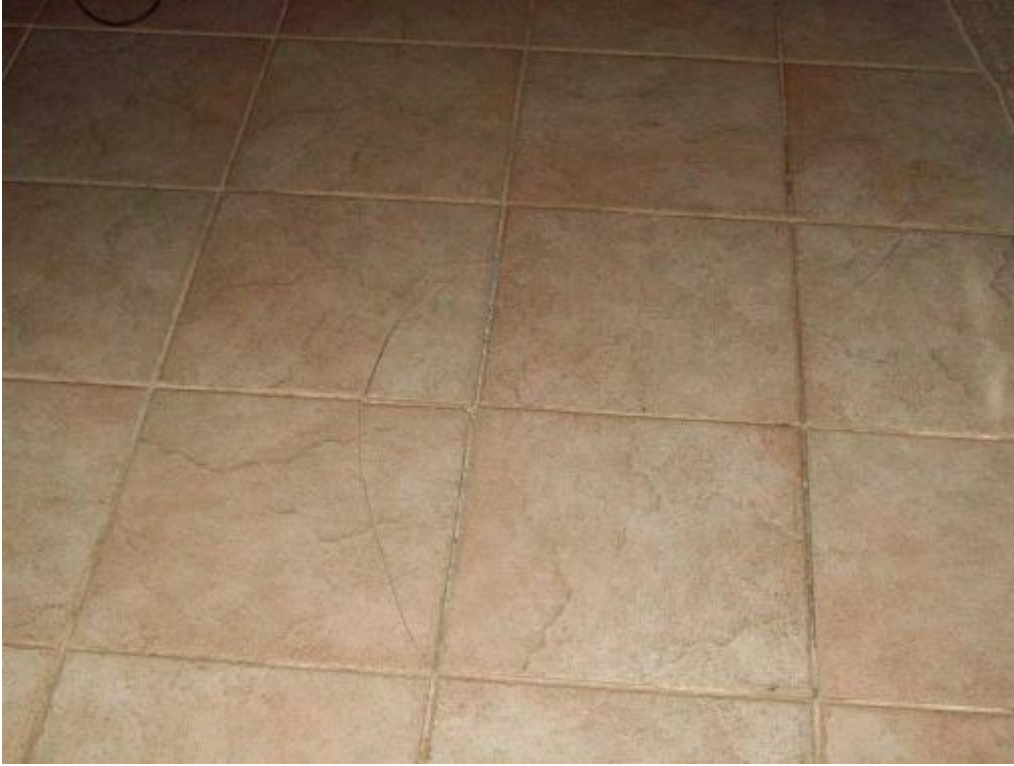
16 Den

More cracked tiles -- this is almost the center of the house.

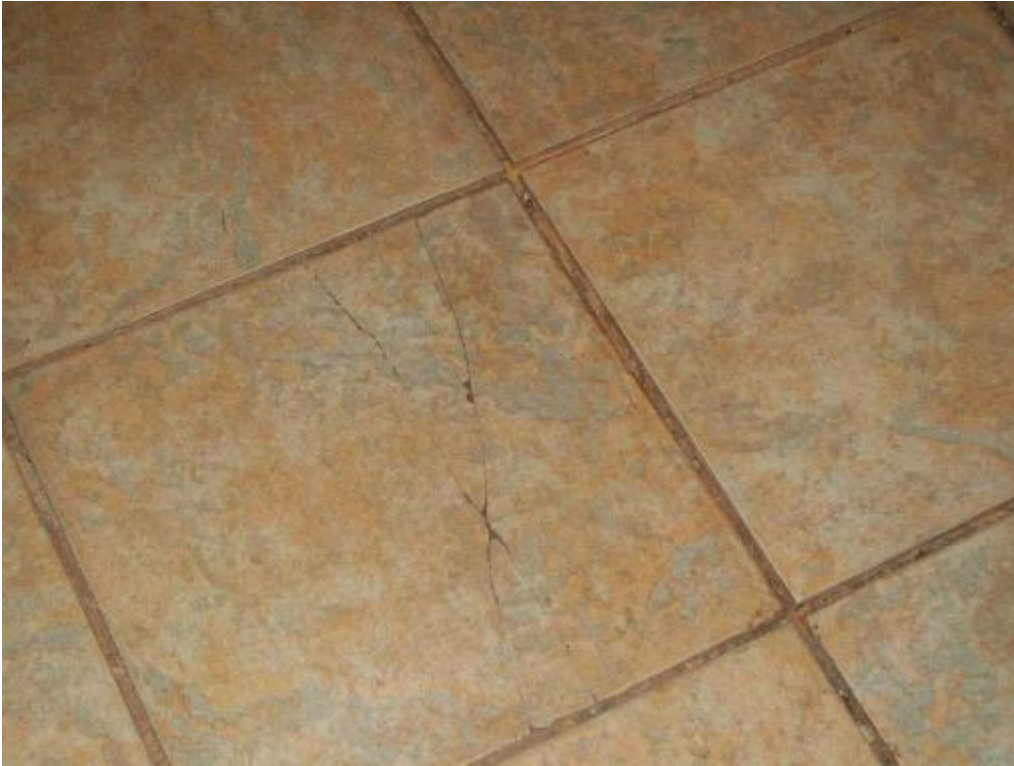
- 17      Hallway                      7/18/2009  
   Taken By:      Butch Bragg  
   Cracked tiles in the center of the hallway -- these are about 20 feet  
   from the ones in the Den area.

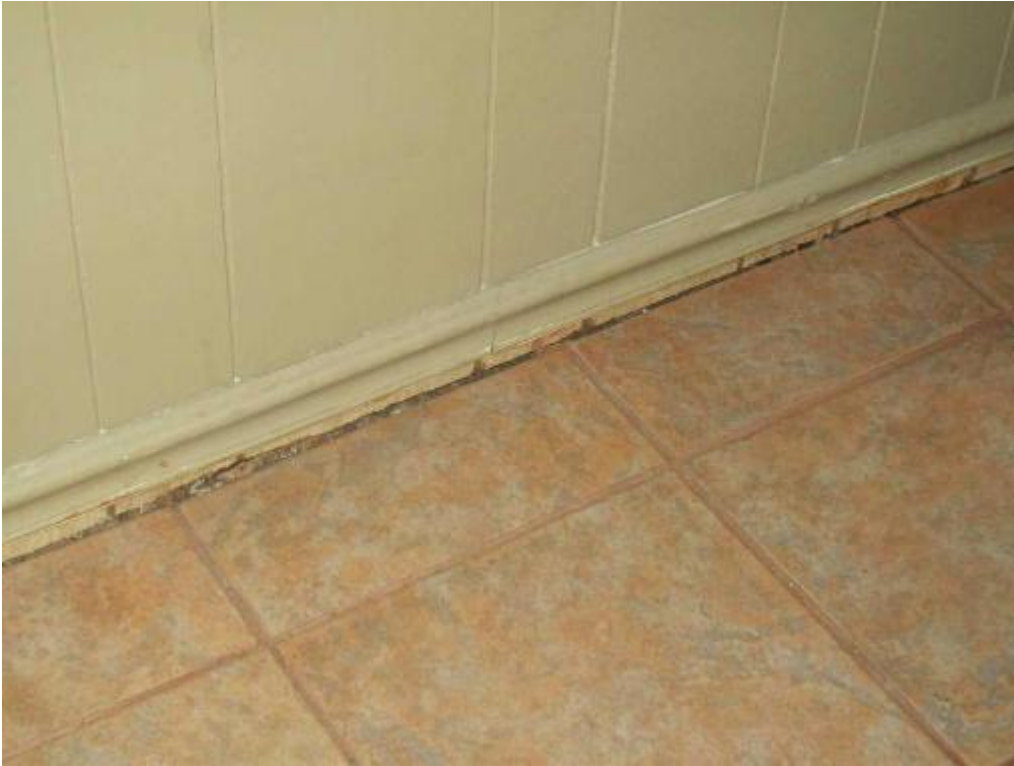
- 18      Hallway                      7/18/2009  
   Taken By:      Butch Bragg  
   Settlement has caused the tiles spacers below the base molding to  
   separate -- this is to be replaced with larger base one foundation  
   and floor repairs are made.

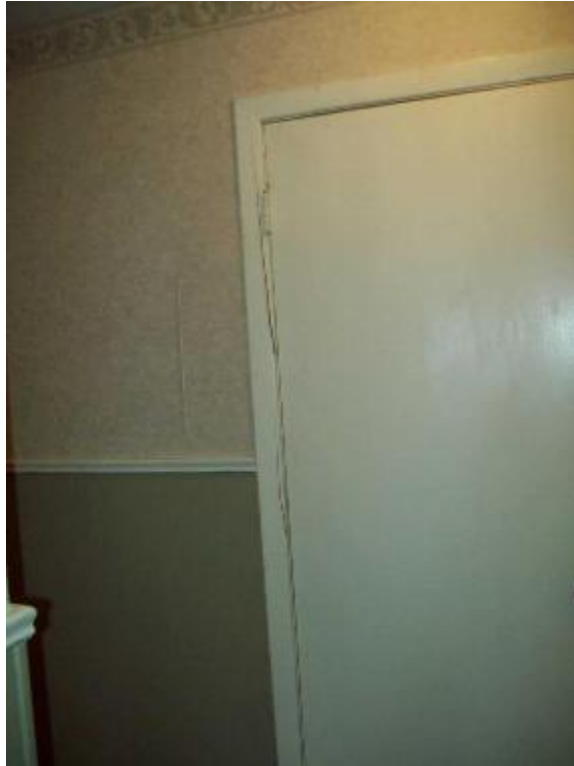
19      Hallway                      7/18/2009  
Taken By:      Butch Bragg  
Damage to door from settlement

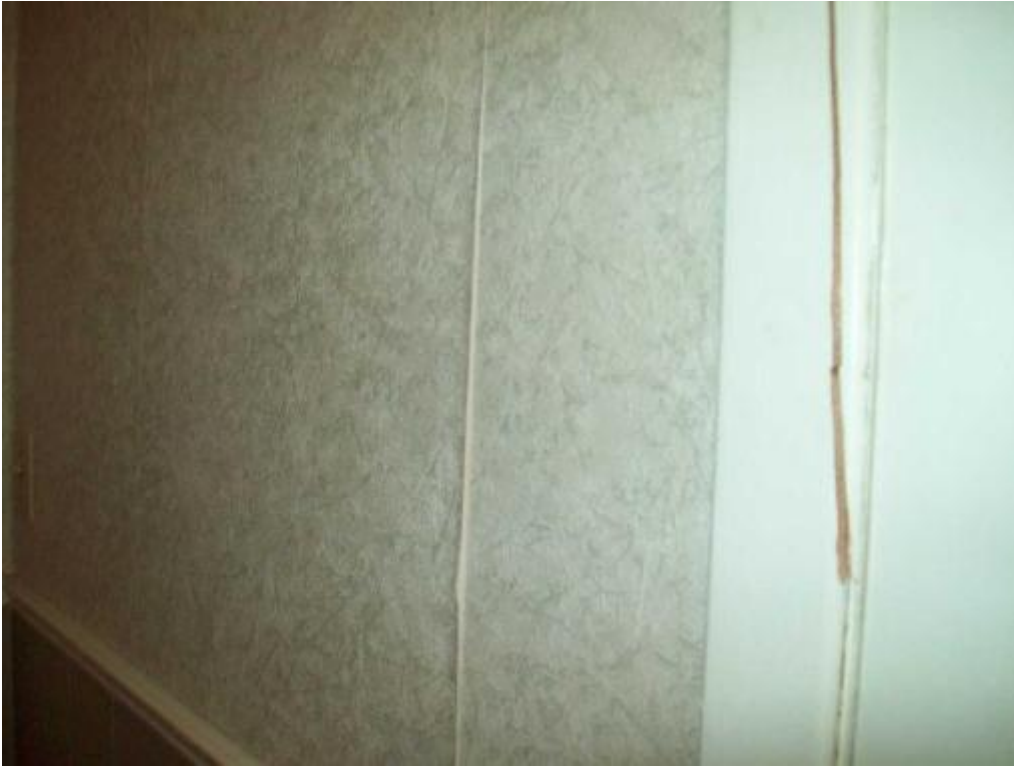
20      Hallway                      7/18/2009  
   Taken By:      Butch Bragg  
   Damage to door and wallpaper coming off the wall from the  
   settlement

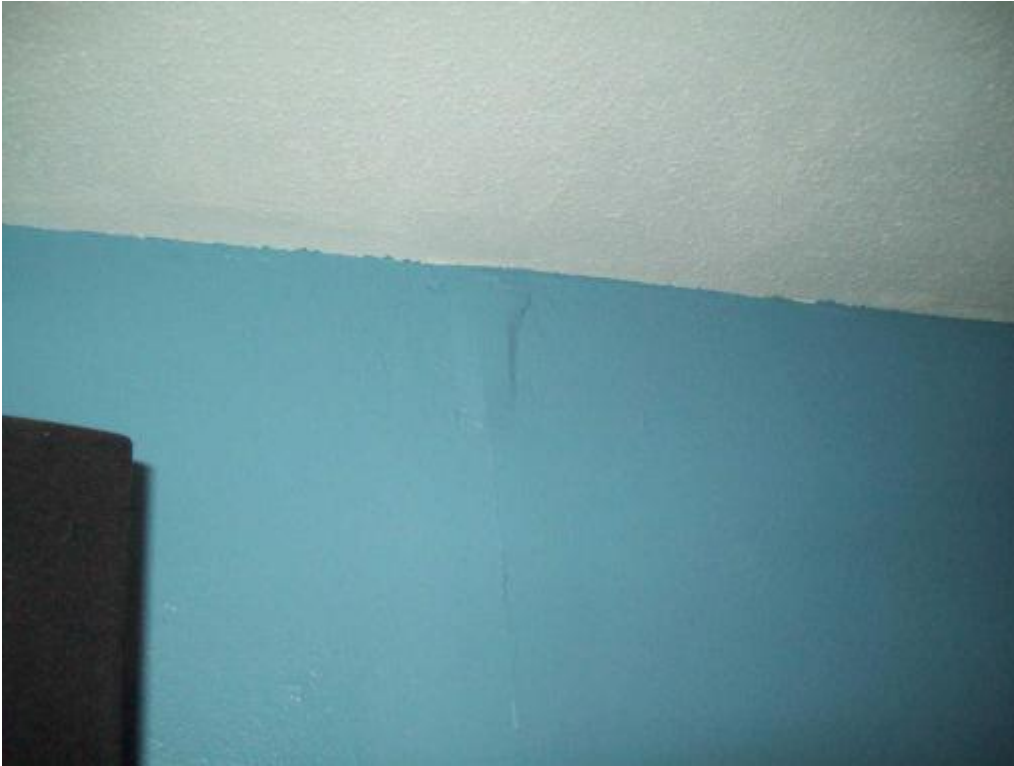
- 21 Boys bedroom 7/18/2009  
Taken By: Butch Bragg  
Damage to bedroom wall from settlement -- note room had  
already been painted and now must be repaired and repainted in  
this area.

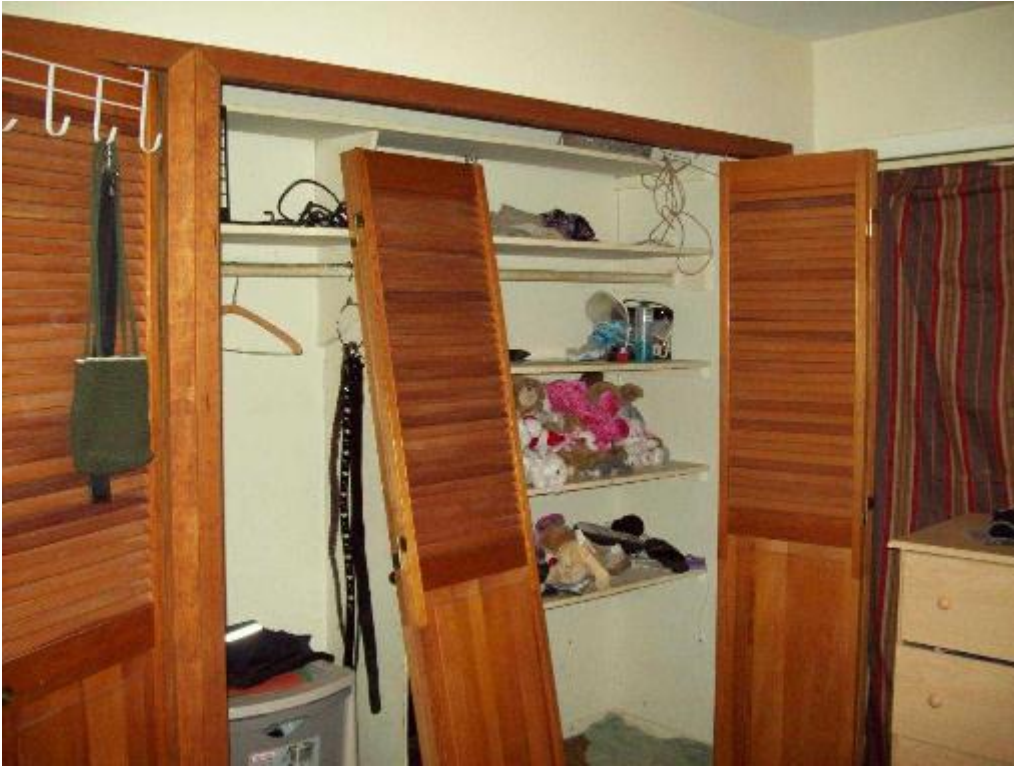
22 Girls bedroom 7/18/2009  
Taken By: Butch Bragg  
Replacement of door hardware components and re-hanging of the door.

DESCRIPTION	QUANTITY	UNIT COST	RCV	DEPREC.	ACV
365. Finish Carpenter - per hour	3.00 HR	62.65	187.95	(0.00)	187.95
<b>Repair closet doors including hardware.</b>					
<b>Totals: girls bedroom</b>			<b>187.95</b>	<b>0.00</b>	<b>187.95</b>

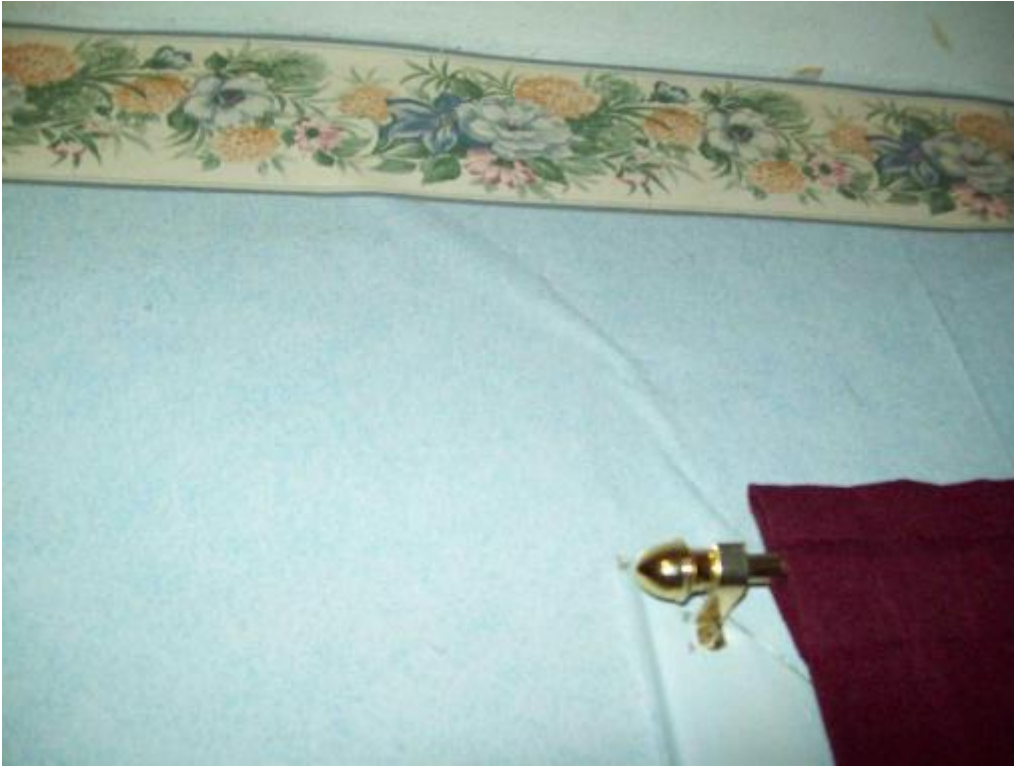
23      Master Bedroom      7/18/2009  
                                 Taken By:      Butch Bragg  
                                 Damage to walls and wallpaper from settlement

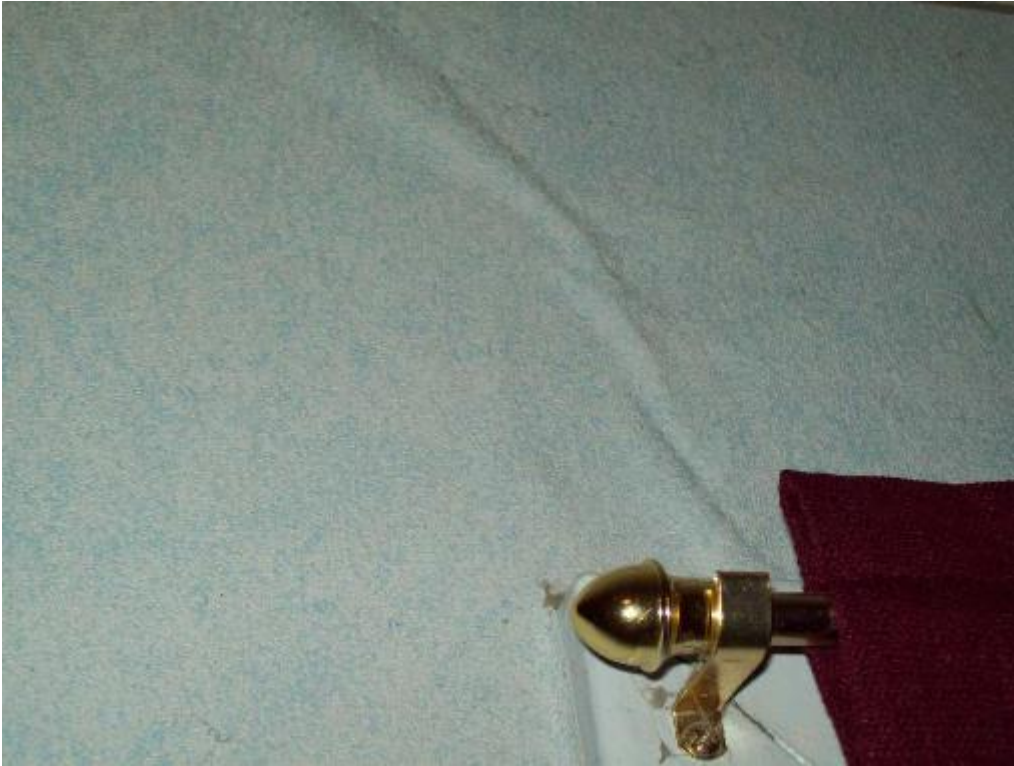
24      Master Bedroom      7/18/2009  
         Taken By:      Butch Bragg  
         Better photo of damage from settlement

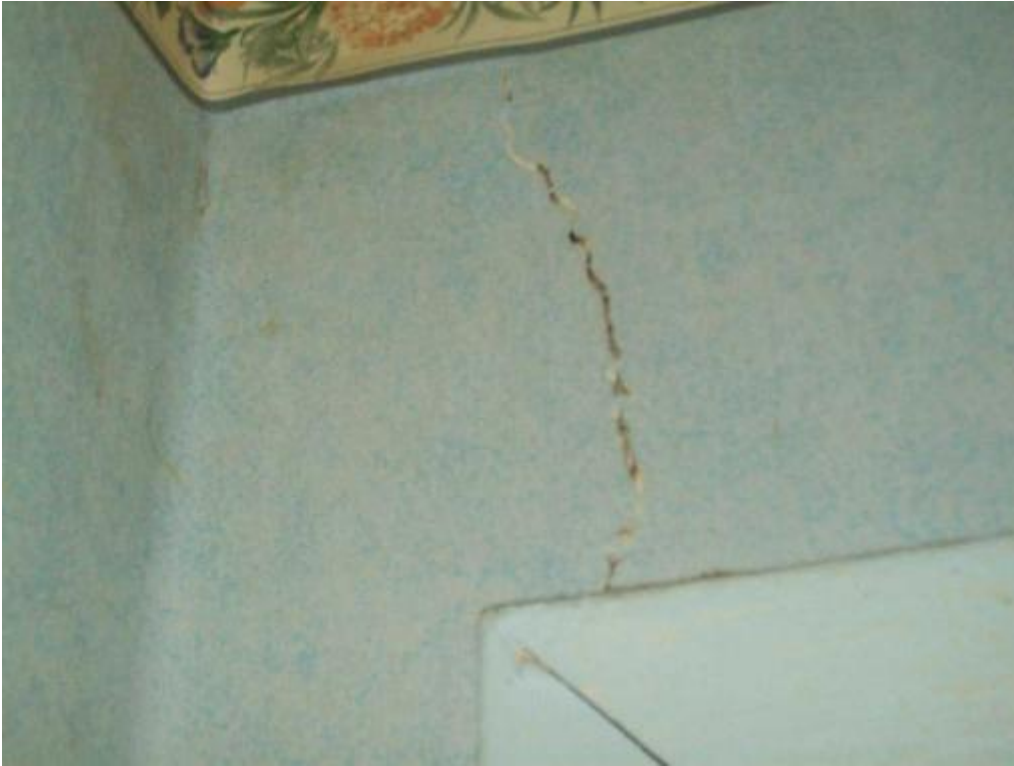
25      Master Bedroom      7/18/2009  
                 Taken By:      Butch Bragg  
                 More damage from settlement

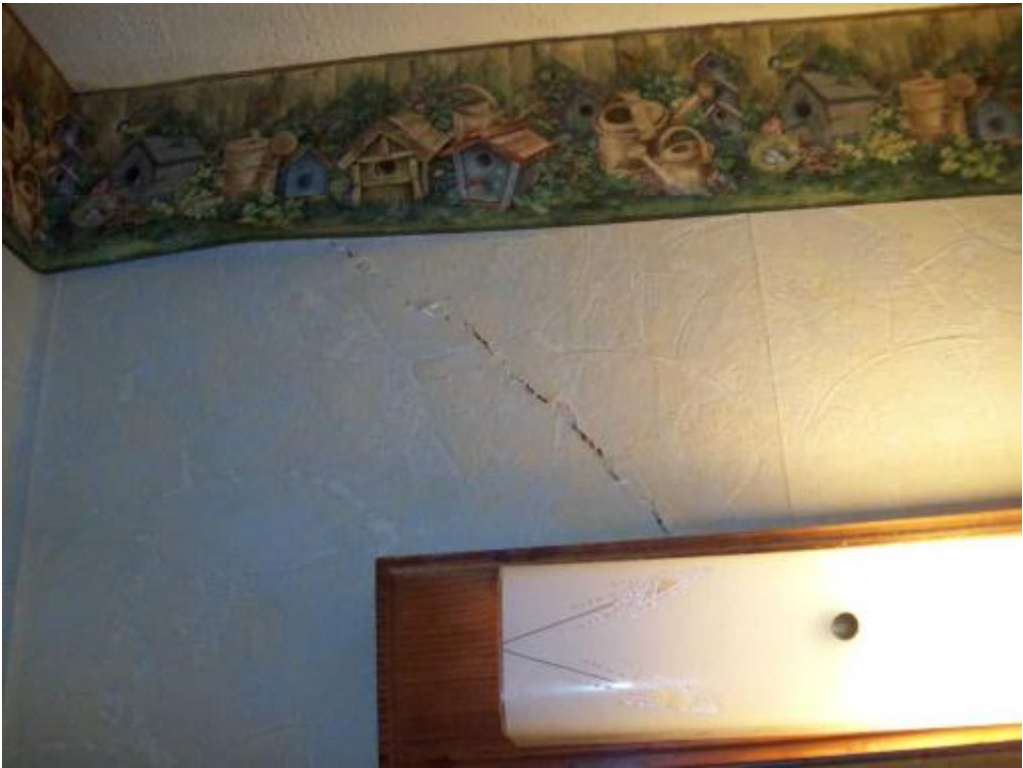
26      Master bath                      7/18/2009  
                 Taken By:      Butch Bragg  
                 Additional damage from settlement in master bedroom bath

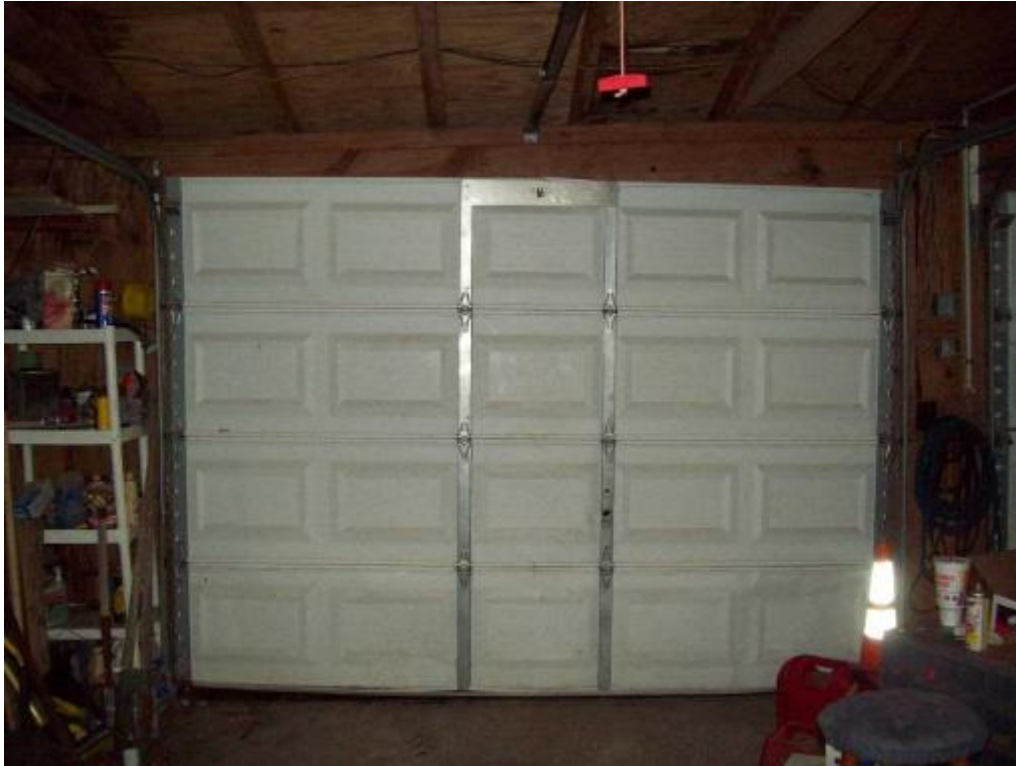
27      Garage/Shop                      7/18/2009  
                 Taken By:      Butch Bragg

Door is setting crooked from left to right because of rot to support beam area. I COULD NOT GET PHOTOS OF THE EXTERIOR SIDES OR THE ROOF AREA FROM THE OUTSIDE AS IT WAS RAINING AT THE TIME I WAS THERE. EXTERIOR WALL HAD BEEN INSPECTED FOR REPLACEMENT EARLIER.

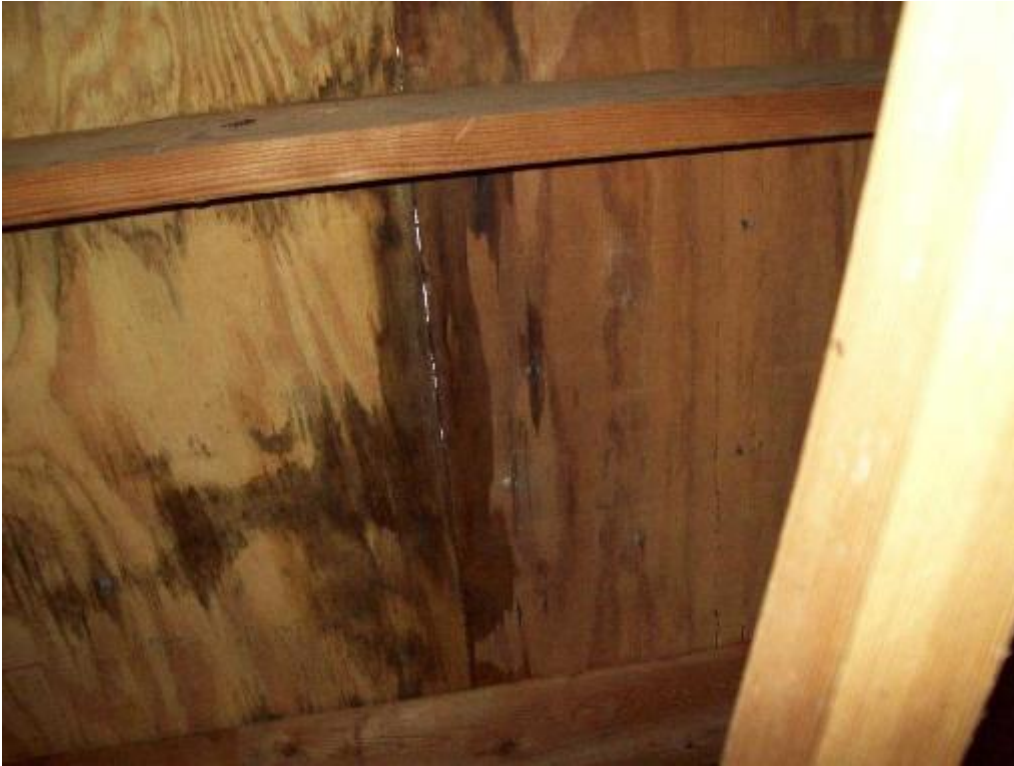
28      Shop roof                      7/18/2009  
                 Taken By:      Butch Bragg  
                 Water damaged area close to the sagging side of the garage door.
