## A- Select Services

Insured: Sample Carport 1  
Property: Any Street  
Pasadena, TX 77505

Price List: TXHO5B\_JAN09  
Restoration/Service/Remodel  
Estimate: SAMPLECARPORT1

**Agreed Estimate and Contract**

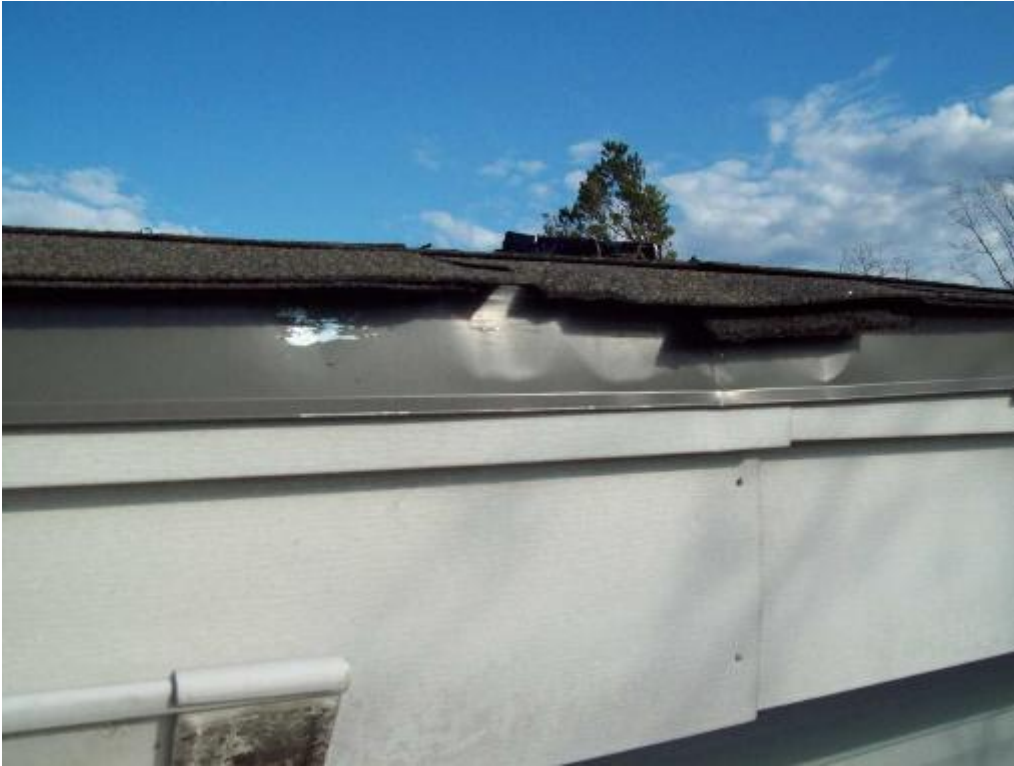
DESCRIPTION	QUANTITY	UNIT COST	RCV	DEPREC.	ACV
4. ROOFING	1.00 EA	350.00	350.00	(0.00)	350.00
Above is to repair shingles damaged where RV cover hit the edge and corner of the house. RV cover was repaired in April of 2008 and the damage repaired was not at the eve of the house but over the driveway end.					
<b>Totals: Roof</b>			<b>350.00</b>	<b>0.00</b>	<b>350.00</b>

- 2      Shingle damage      1/6/2009  
         Taken By:      Butch Bragg  
                         Shingle damage to roof from RV cover

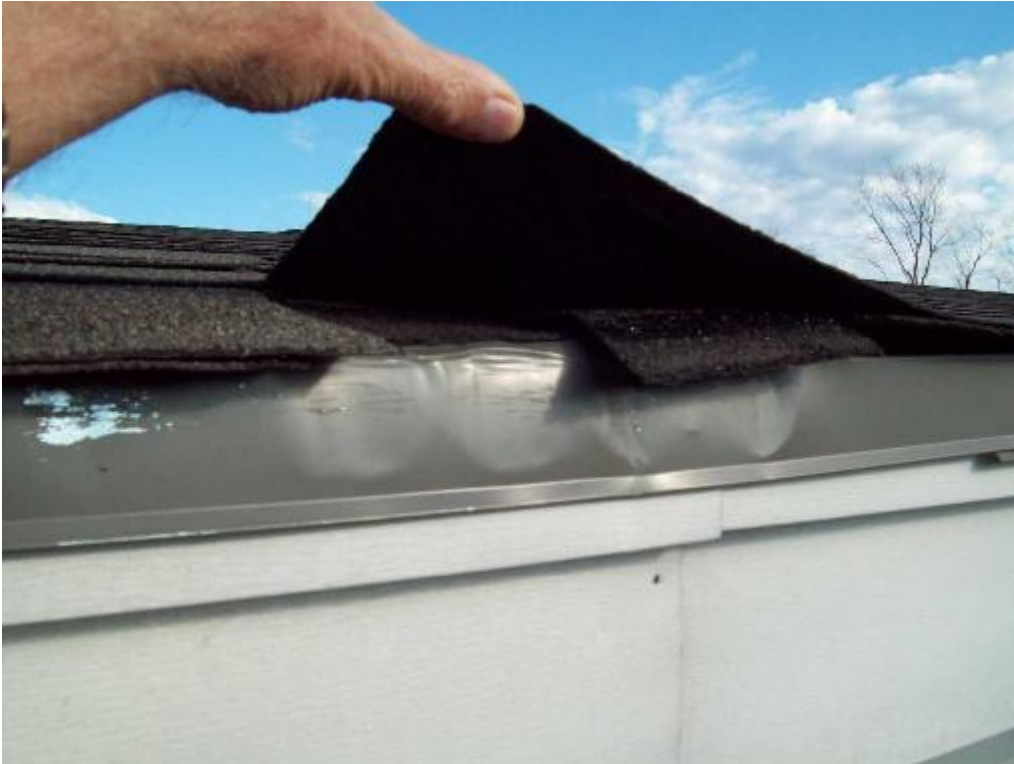
- 3      Shingle damage      1/6/2009  
         Taken By:      Butch Bragg  
                         Shingle damage to roof from RV cover

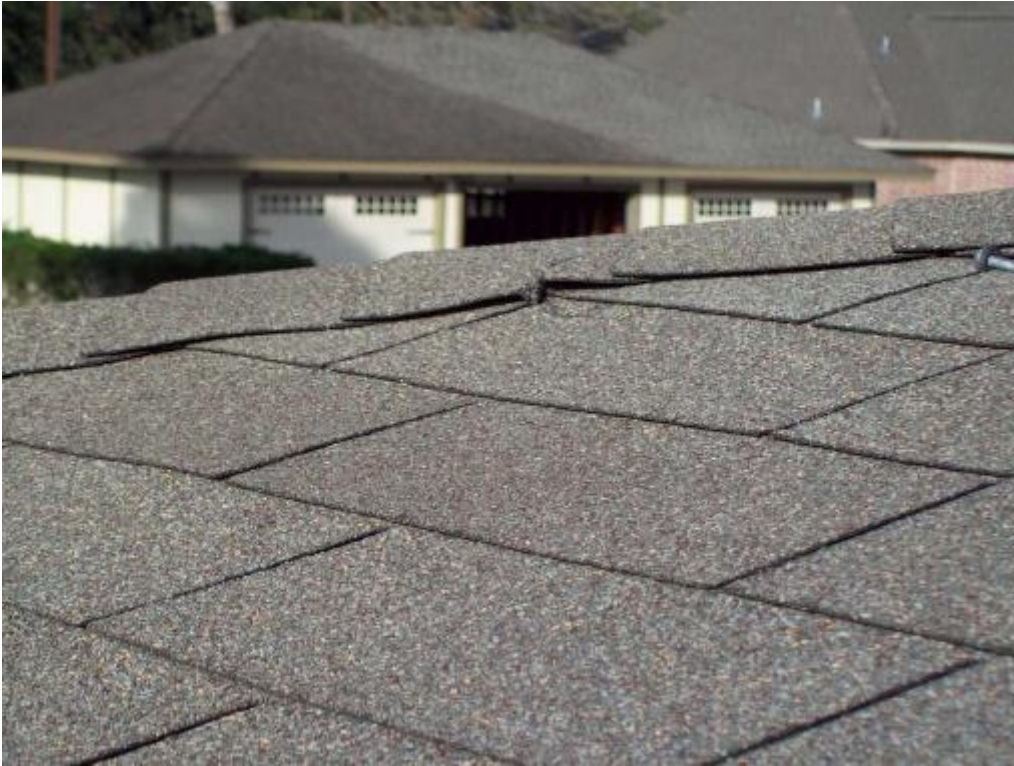
- 4 Ridge damage 1/6/2009  
Taken By: Butch Bragg  
Damaged Ridge cap from RV cover

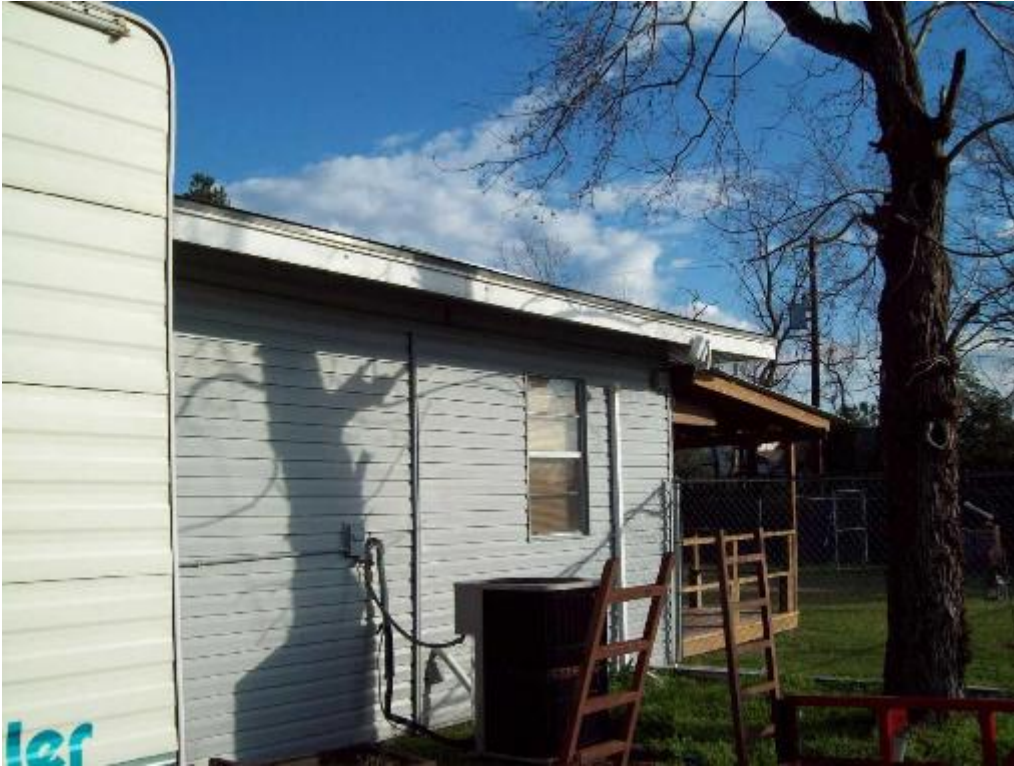
DESCRIPTION	QUANTITY	UNIT COST	RCV	DEPREC.	ACV
3. R&R Gutter / downspout - plastic	30.00 LF	4.12	123.60	(0.00)	123.60
<b>Gutter not listed on estimate.</b>					
<b>Total: Right Elevation</b>			<b>123.60</b>	<b>0.00</b>	<b>123.60</b>

- 5 Missing gutter 1/6/2009  
Taken By: Butch Bragg  
Missing vinyl gutter

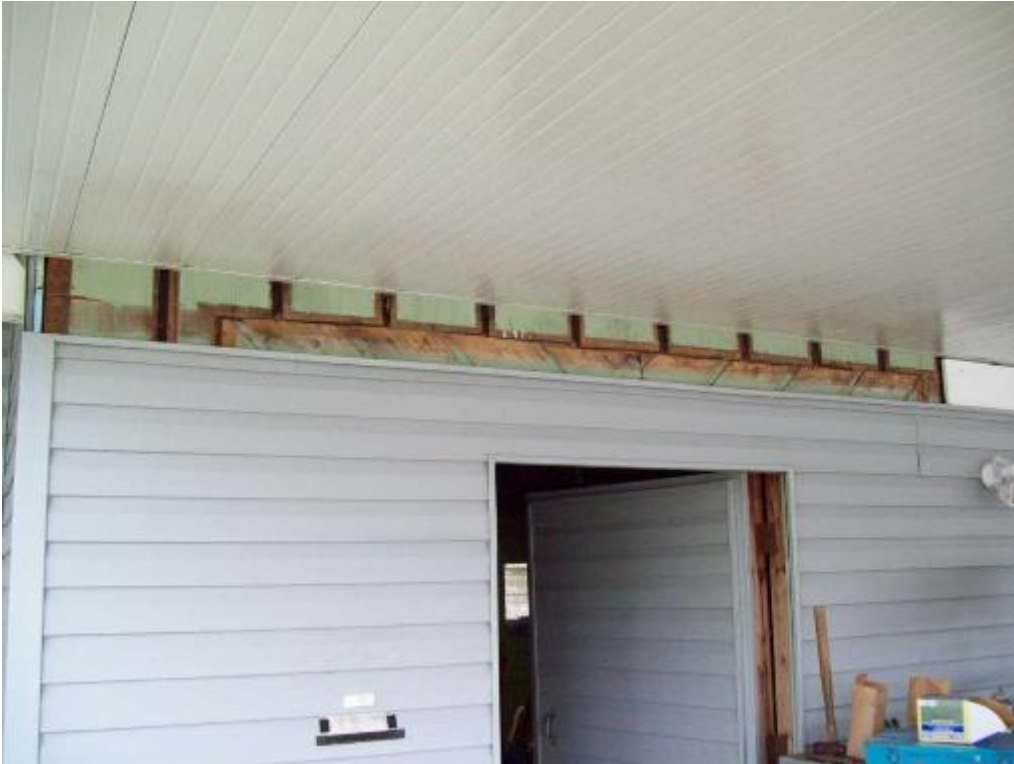
- 6 Attachment area 2/27/2009  
Taken By: Butch Bragg  
Area where carport was attached and start of repair to damage --  
repair not listed on estimate.

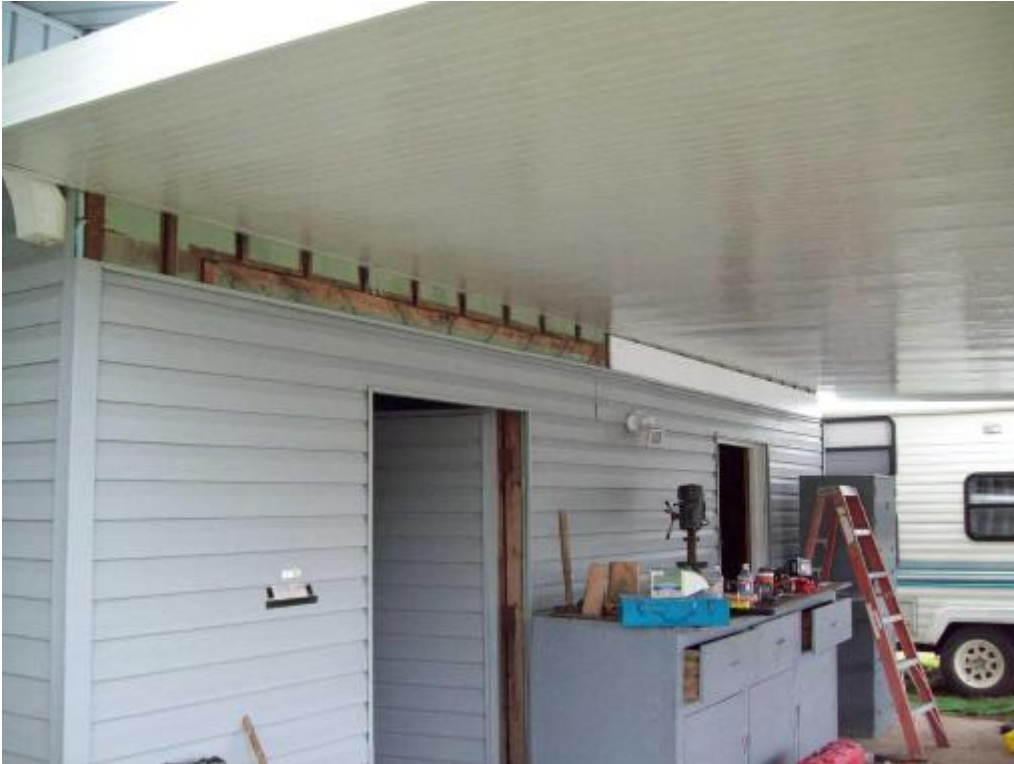
- 7      Repair to attachment      2/27/2009  
         Taken By:      Butch Bragg  
         Carport had to be raised because of damage to get to a solid attachment.

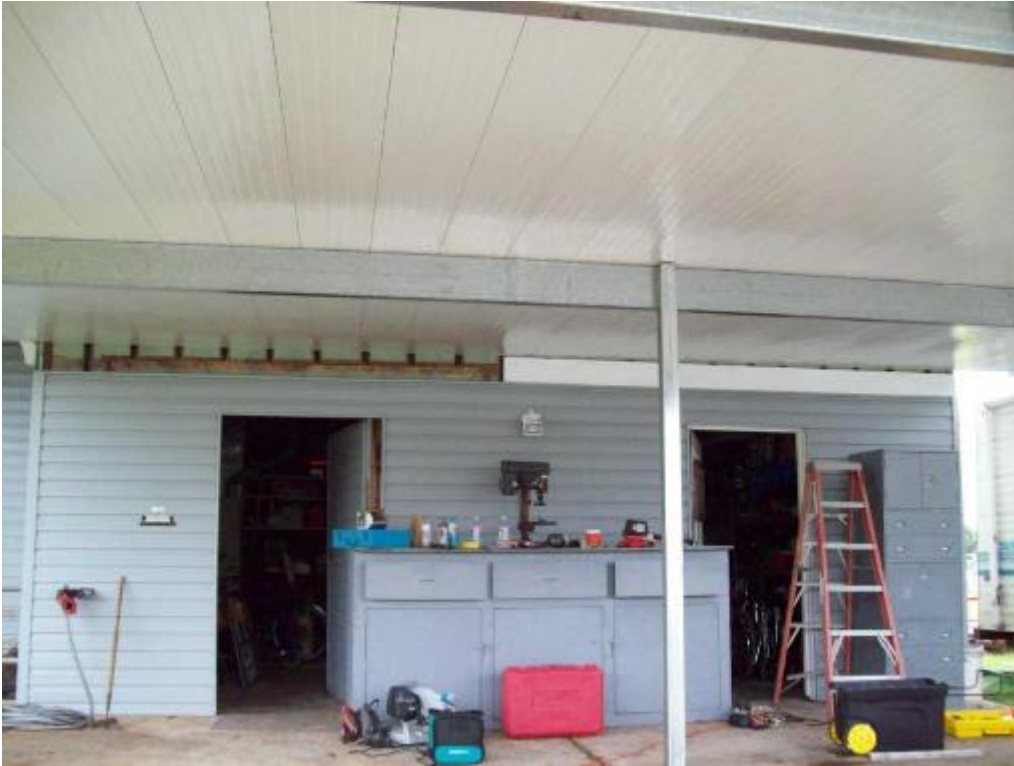
- 8      Front view                      2/27/2009  
         Taken By:      Butch Bragg  
                                 New carport with repair to attachment area from old carport  
                                 damage.
