A- Select Services

Insured: Sample Alum. Roof and Misc.
Property: Any Street
Houston, TX 77035

Price List: TXHO5B_JAN09
Restoration/Service/Remodel
Estimate: SAMPLEALUMROOF1

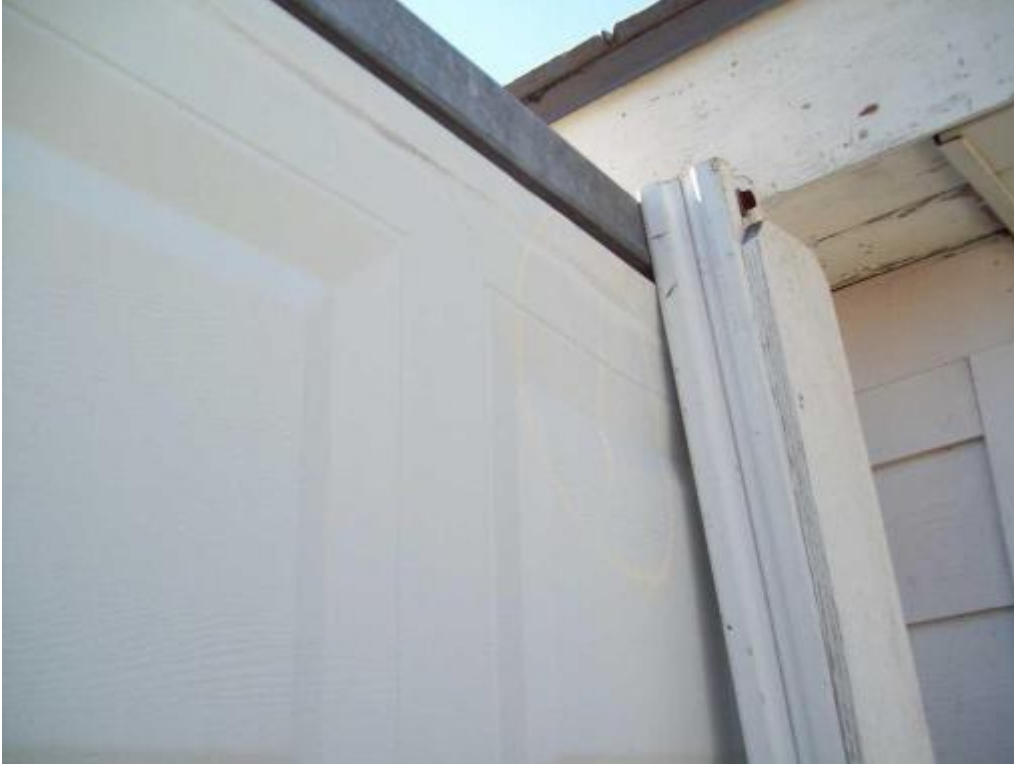
- 1 Gate/Garage door 2/20/2009
Taken By: Butch Bragg
Damage to top panel

DESCRIPTION	QUANTITY	UNIT COST	RCV	DEPREC.	ACV
11. R&R Wood fence 5'- 6' high - cedar	40.00 LF	30.75	1,230.00	(0.00)	1,230.00
12. R&R Overhead door & hardware - 8'x 7' - Standard grade	1.00 EA	509.49	509.49	(0.00)	509.49
Door was actually used as a gate. All four panels were damaged as well as the overhead rail used to roll the gate open and closed. Door must be bought with all hardware as a kit as per ABC Overhead door -- this is actually less than replacing all four panels per panel in Xact.					
13. Fencing Installer - per hour	4.00 HR	59.00	236.00	(0.00)	236.00
Above is for the labor to re-set the overhead rail and posts that line it up to open and close.					
Totals: Fencing			1,975.49	0.00	1,975.49

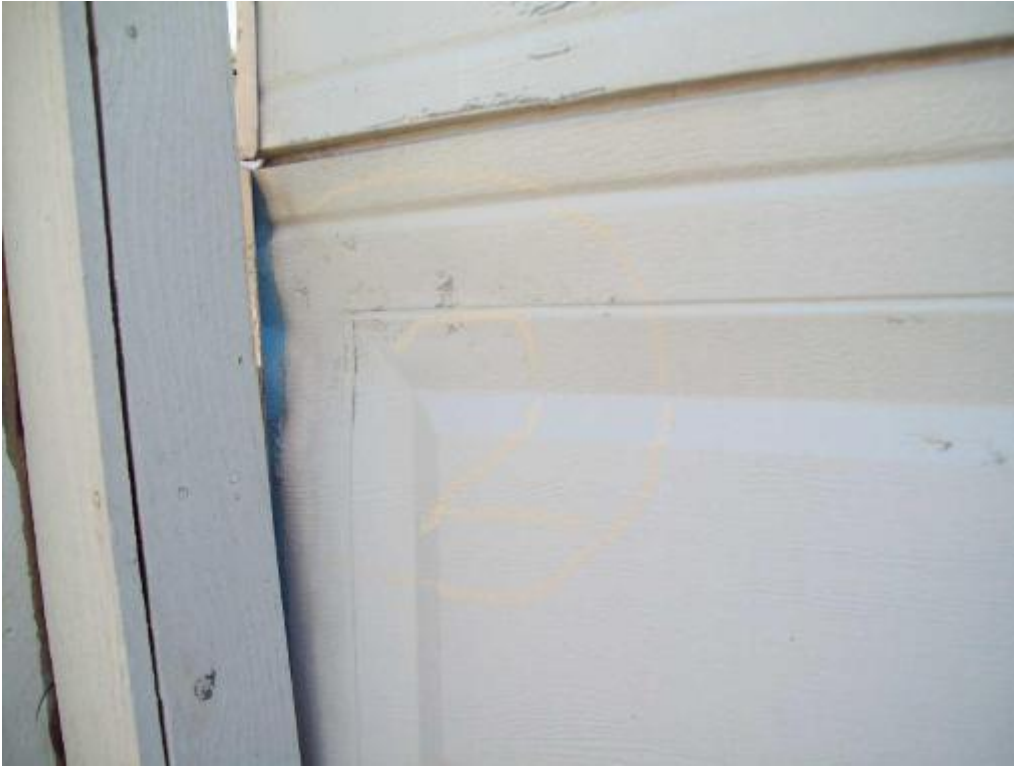
- 2 Gate/garage door 2/20/2009
Taken By: Butch Bragg
Second panel from top damage

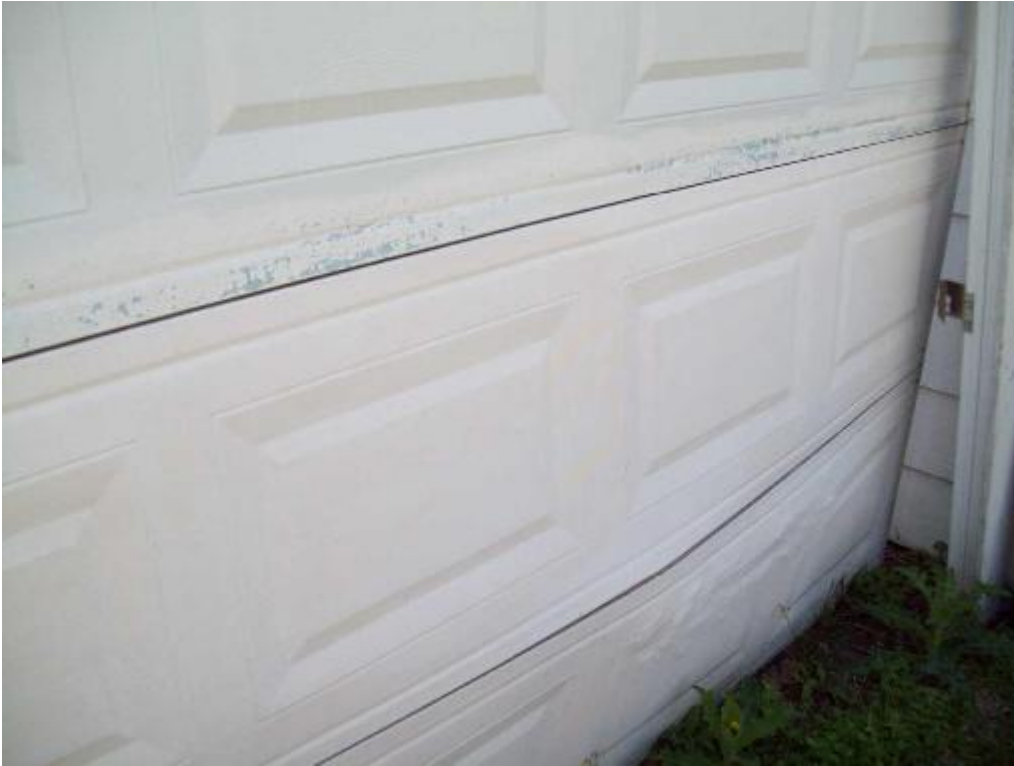
- 3 Gate/Garage door 2/20/2009
Taken By: Butch Bragg
Damage to both lower panels

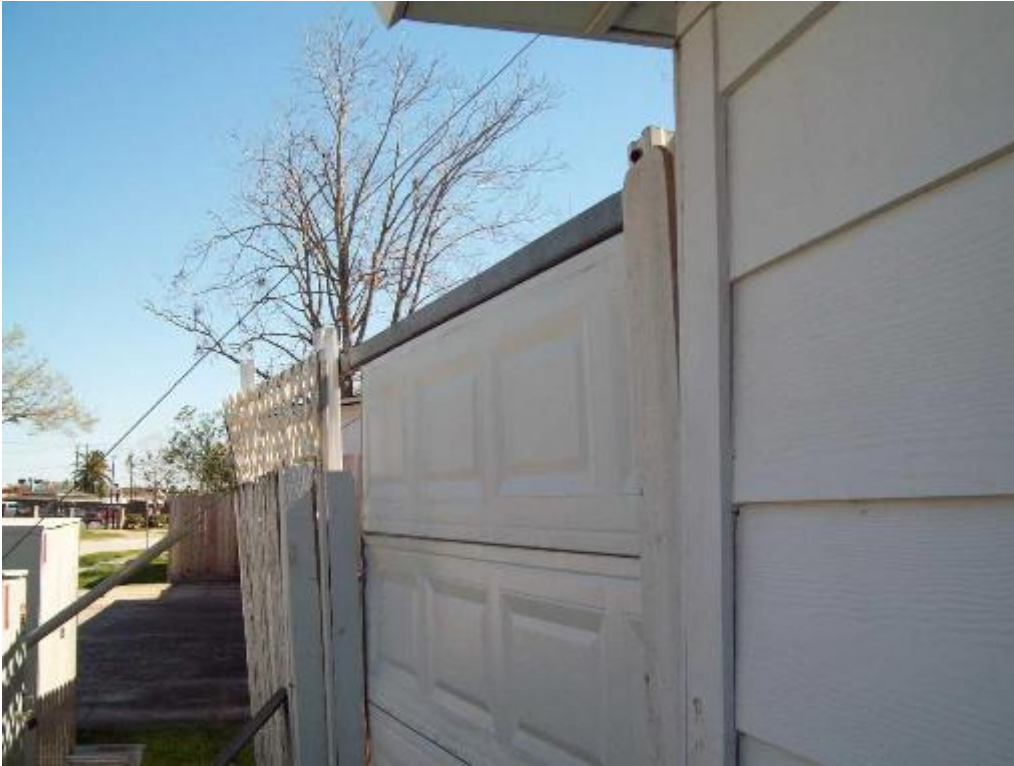
- 4 Gate/garage door 2/20/2009
Taken By: Butch Bragg
View of door twisted out of alignment.

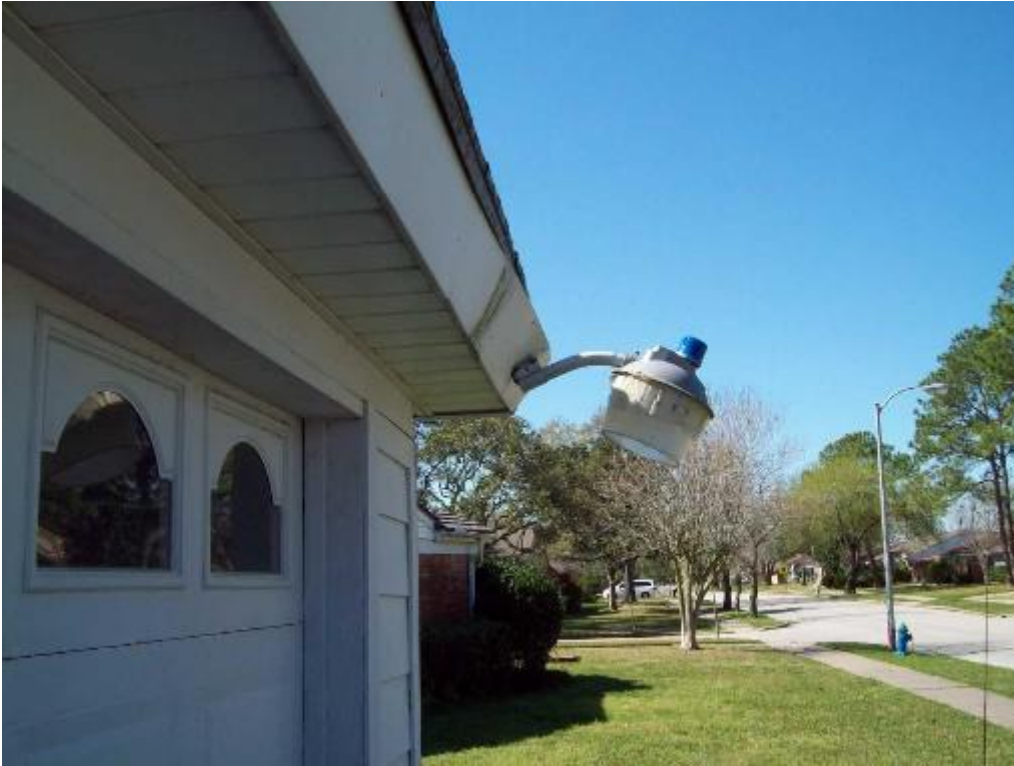
- 5 Front of garage 2/20/2009
Taken By: Butch Bragg
Fascia is bent and light is damaged.

DESCRIPTION	QUANTITY	UNIT COST	RCV	DEPREC.	ACV
15. R&R Fascia - metal, 8"	24.00 LF	3.54	84.96	(0.00)	84.96
Replace fascia on front of garage where light is detached.

16. R&R Exterior light fixture - High grade	1.00 EA	104.28	104.28	(0.00)	104.28
Above is to replace exterior Mercury vapor light damaged in hurricane on front of garage.

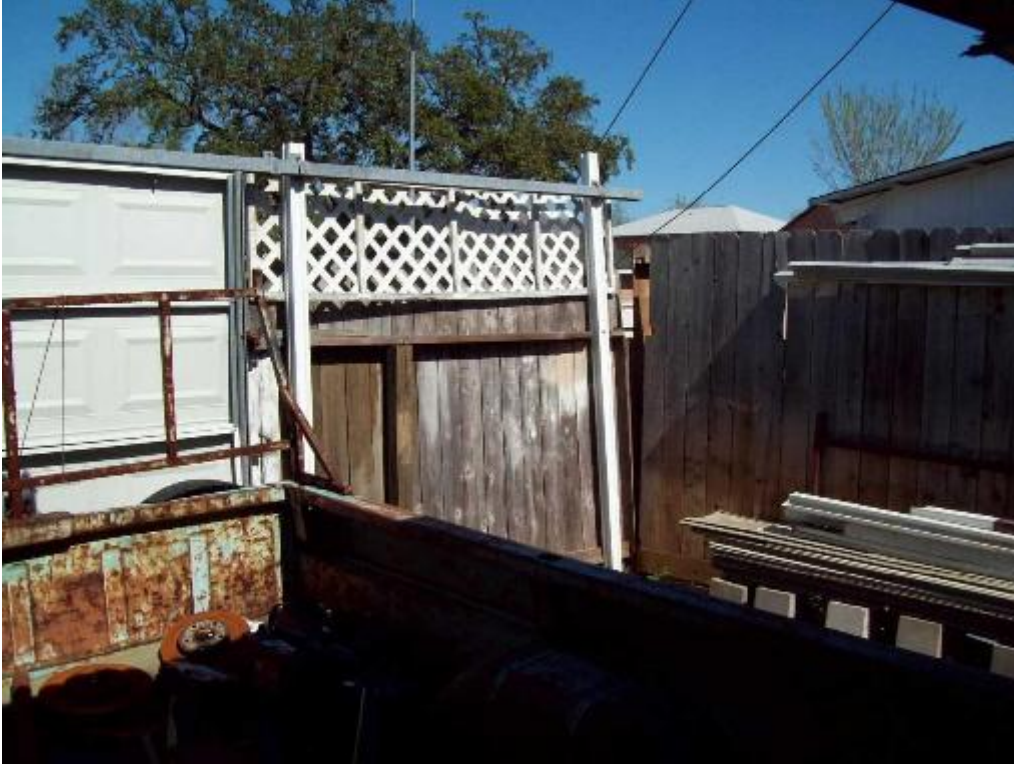
- 6 Gate rail and posts 2/20/2009
Taken By: Butch Bragg
Posts and rail will have to be removed and re-set to line up rollers on door/gate.

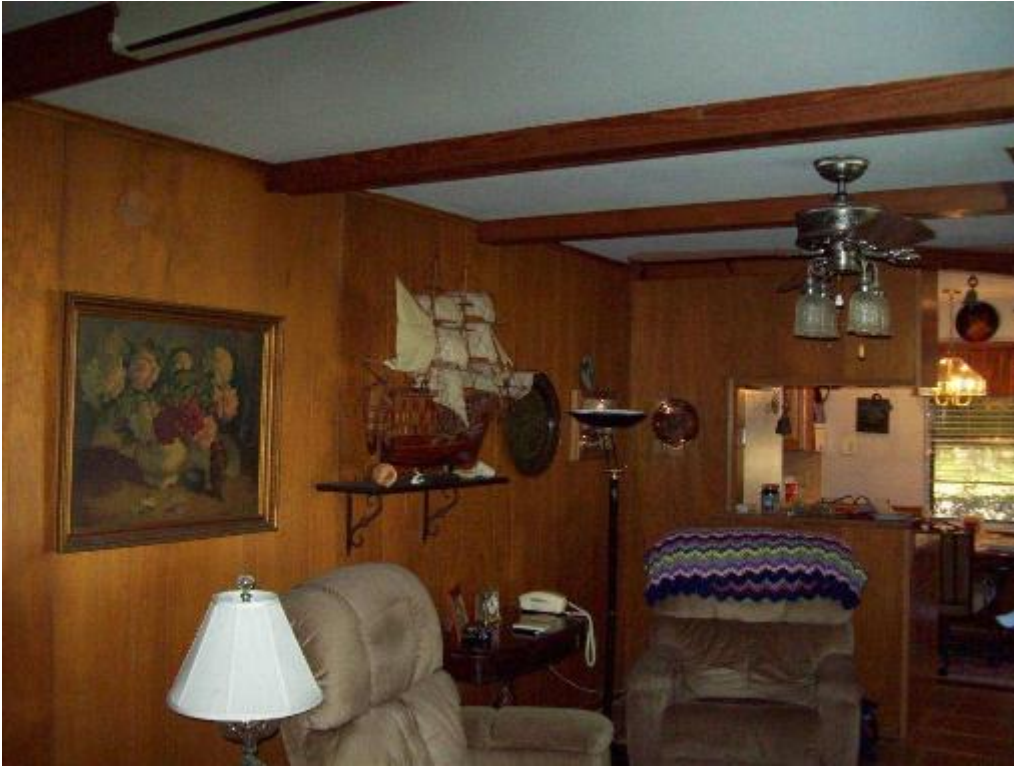
- 7 Living room 2/20/2009
Taken By: Butch Bragg
Overview of room showing fan and beams not accounted for in estimate for repairs.

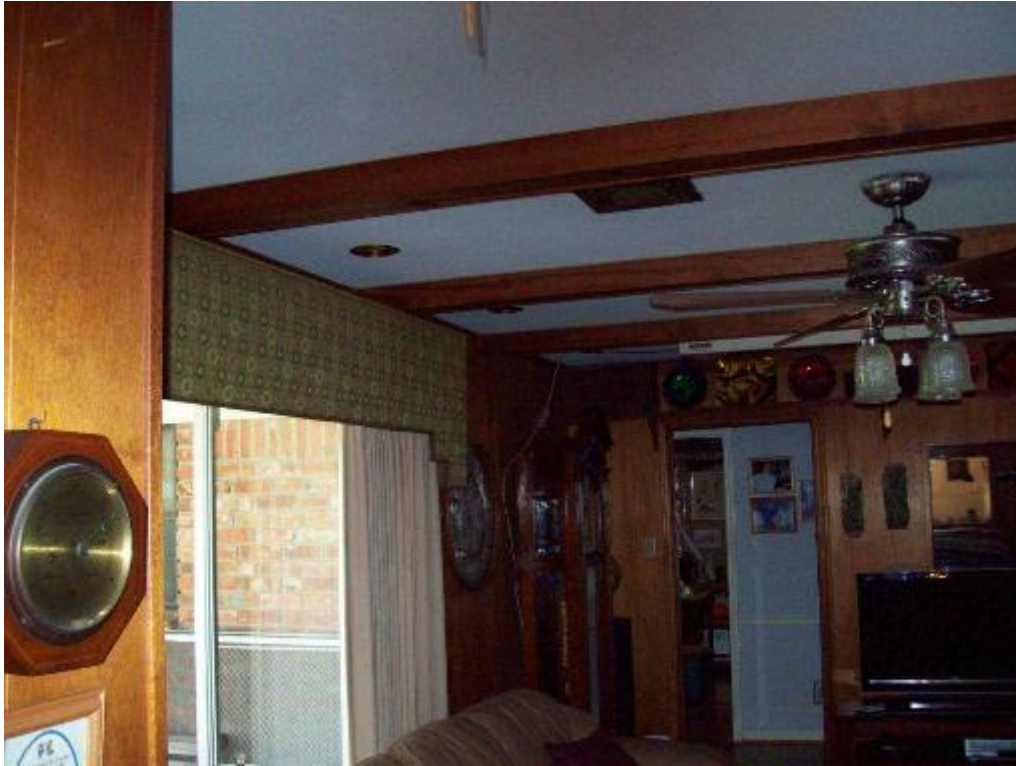
- 8 Living room 2/20/2009
Taken By: Butch Bragg
Additional photos of fan and stained beams.

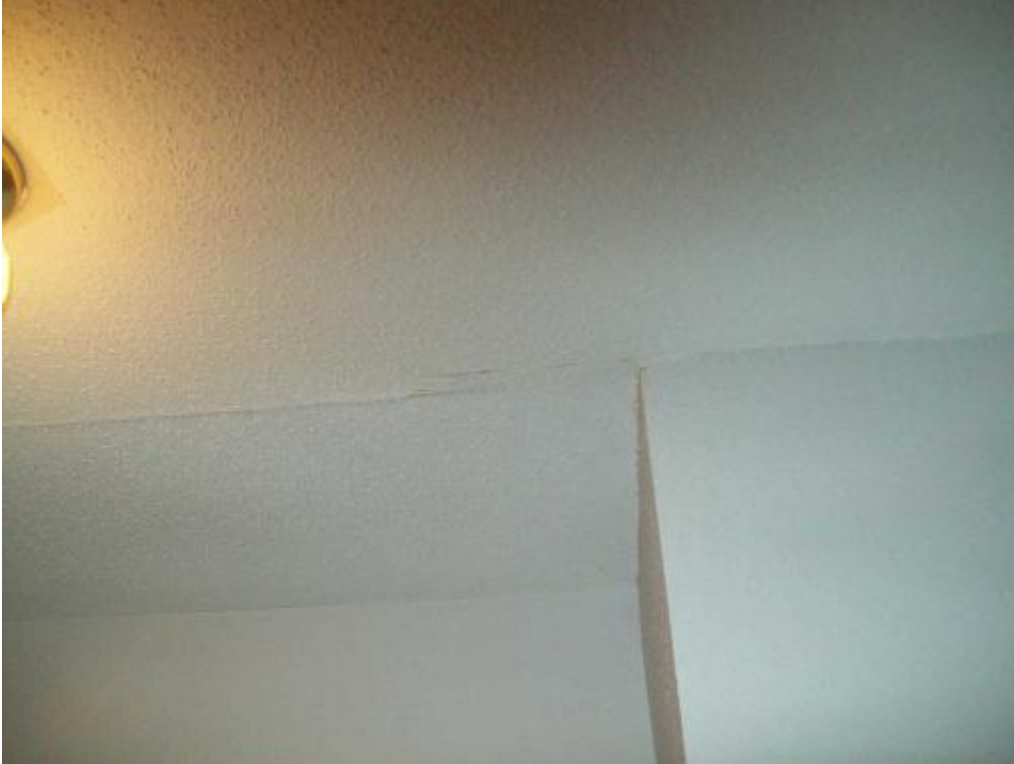
9 Hallway 2/20/2009
 Taken By: Butch Bragg
 Split in drywall

DESCRIPTION	QUANTITY	UNIT COST	RCV	DEPREC.	ACV
38. Drywall tape joint/repair - per LF	6.00 LF	5.78	34.68	(0.00)	34.68
39. Spot seal / prime	1.00 EA	16.17	16.17	(0.00)	16.17
40. Paint the surface area - one coat	487.05 SF	0.37	180.21	(0.00)	180.21
Repair will cause walls and ceiling to both need to be painted.					
41. Mask and cover light fixture	3.00 EA	9.23	27.69	(0.00)	27.69
Totals: Hallway			258.75	0.00	258.75

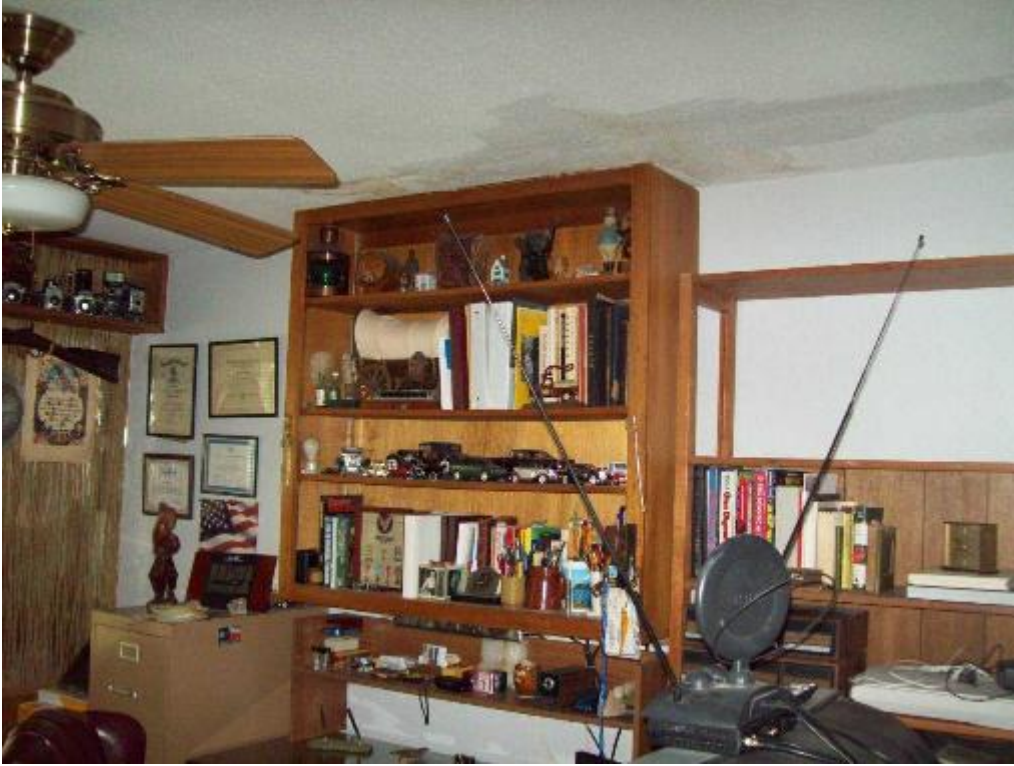
10 Office

Damaged area and just some of the numerous contents. This area is still getting wet as a settlement cannot be reached on the roof and tarping this roof is almost impossible in this area.

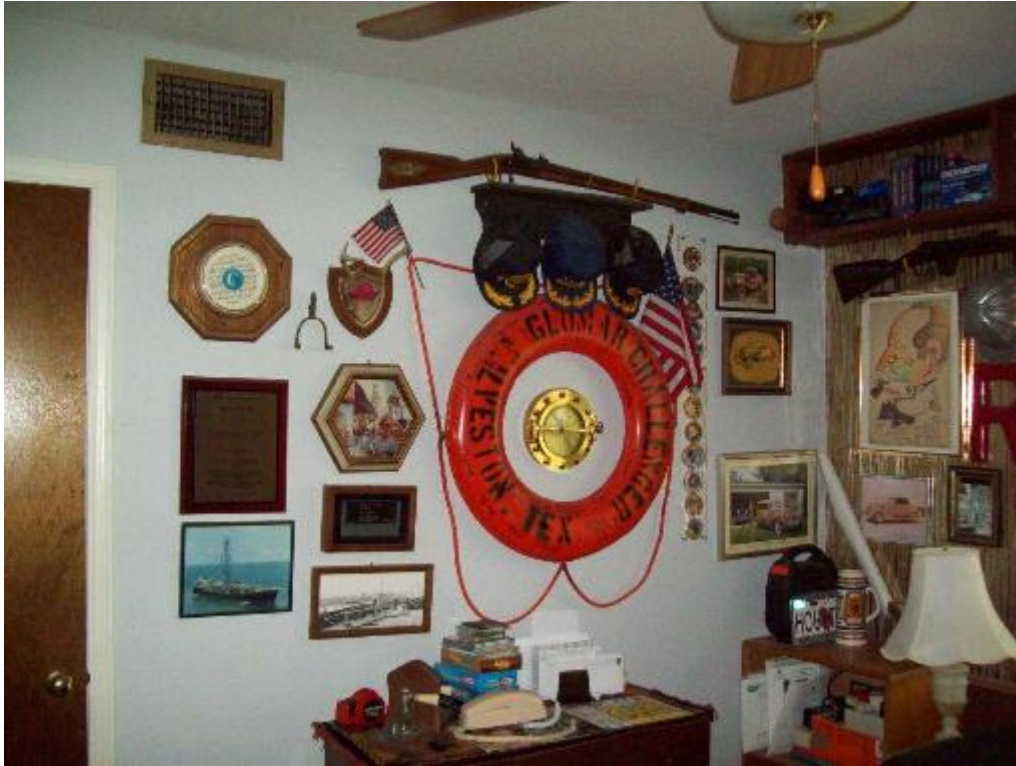
11 Office

Additional contents to be removed and stored during repair.
