A- Select Services

Insured: Sample file 1
Property: Any Street
PASADENA, TX 77505

| Claim Number: | Policy Number: | Type of Loss: Wind Damage | |

Price List: TXHO5B_MAY09
Restoration/Service/Remodel
Estimate: SAMPLEFILE1

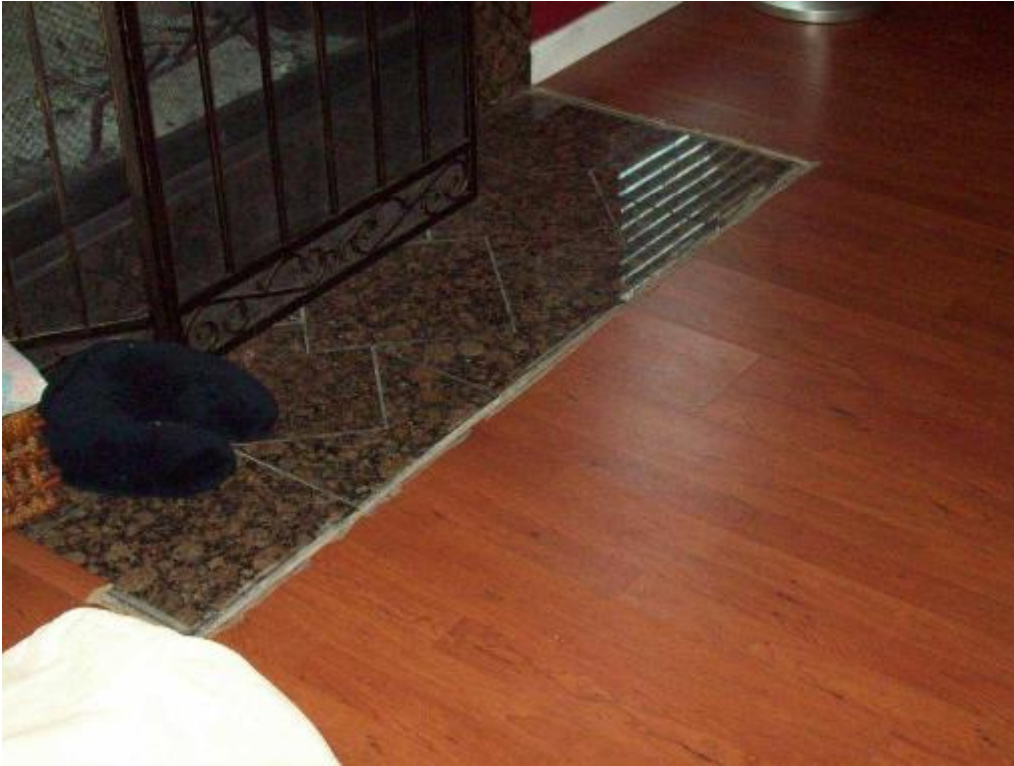
WATER LEAKED DOWN INTO & AROUND THE CHIMNEY ALLOWING WATER TO PENETRATE THE INTERIOR & FLOW UNDER THE WOOD FLOORING. THE FLOORING THROUGHOUT THE LIVING ROOM, ENTRY HALL & THE DINING ROOM IS WARPING & THE JOINTS ARE LIFTING.

- 1 Den 7/1/2009
Taken By: Butch Bragg
One of the damaged areas where water entered.

The above Laminated flooring is a "floating" laminated floor -- in places there was over an inch of water standing over more than 20% of the area in this room. Laminate flooring cannot sustain water penetration without permanent damage. This floor runs through this room -- the master bedroom -- and into the dining room -- it is all the same floor and cannot just be repaired in specific areas. Water entered at the fireplace which ran into the master bedroom as well as the den. It is clear the moisture under these areas has effected all the connected wood flooring. All flooring will need to be removed and replaced.

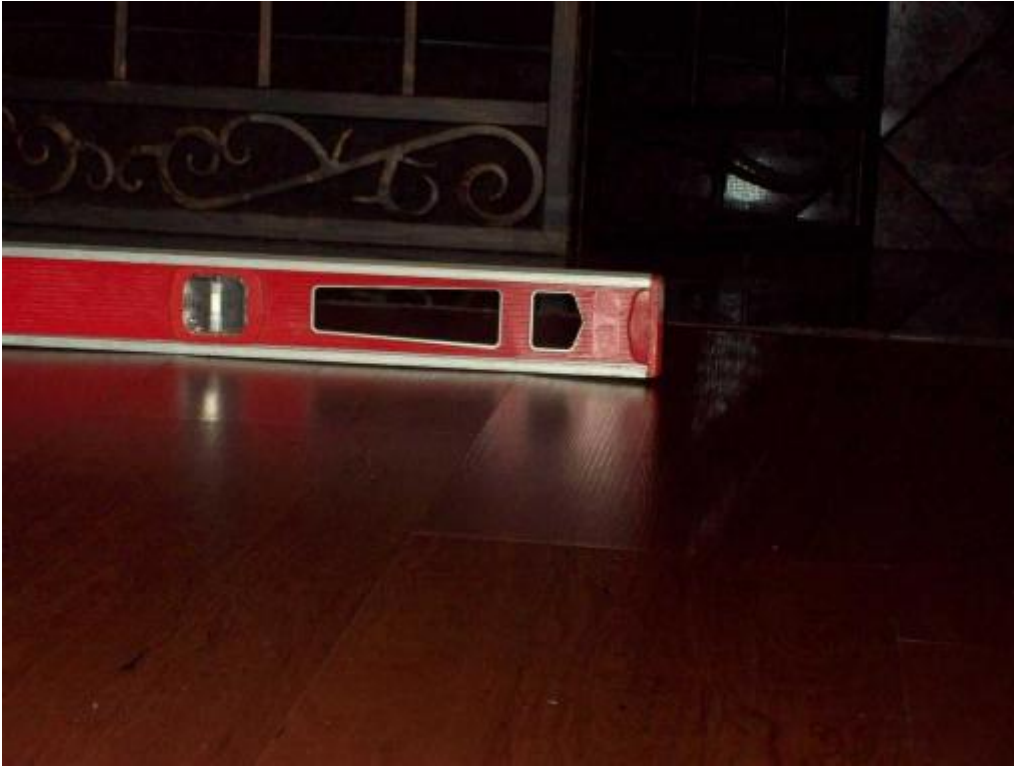
2 Den 7/1/2009
Taken By: Butch Bragg
Damaged floor -- note space under level

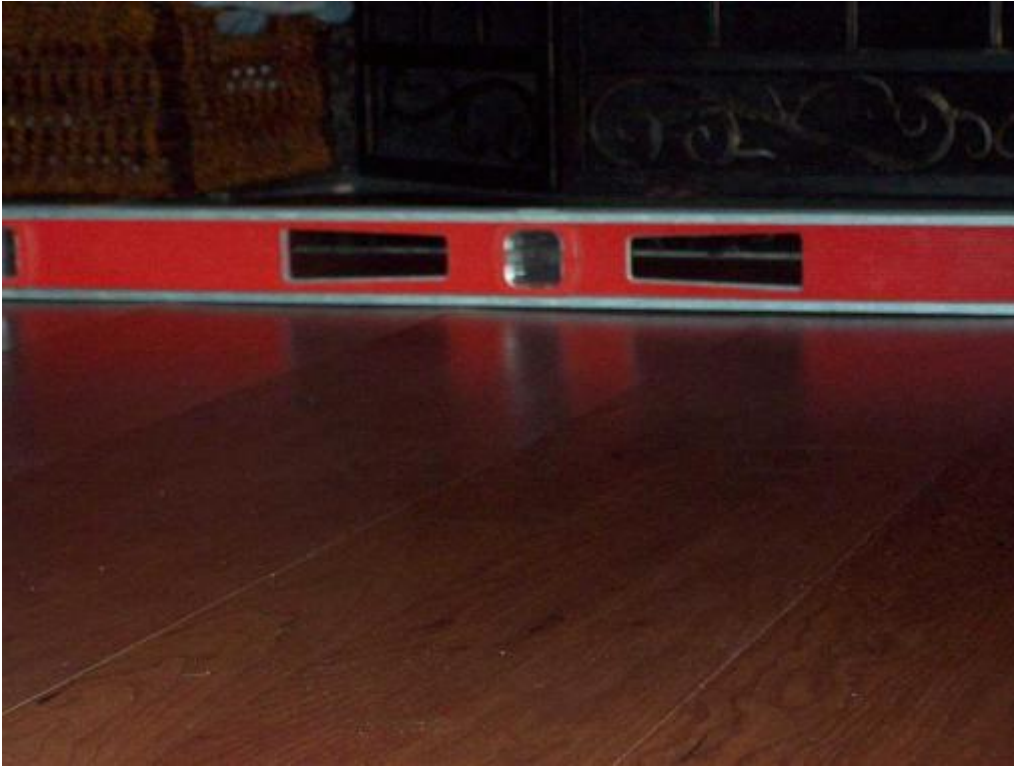
- 3 Damaged floor 7/1/2009
 Taken By: Butch Bragg
 Note space under level -- this is consistent in all affected rooms.

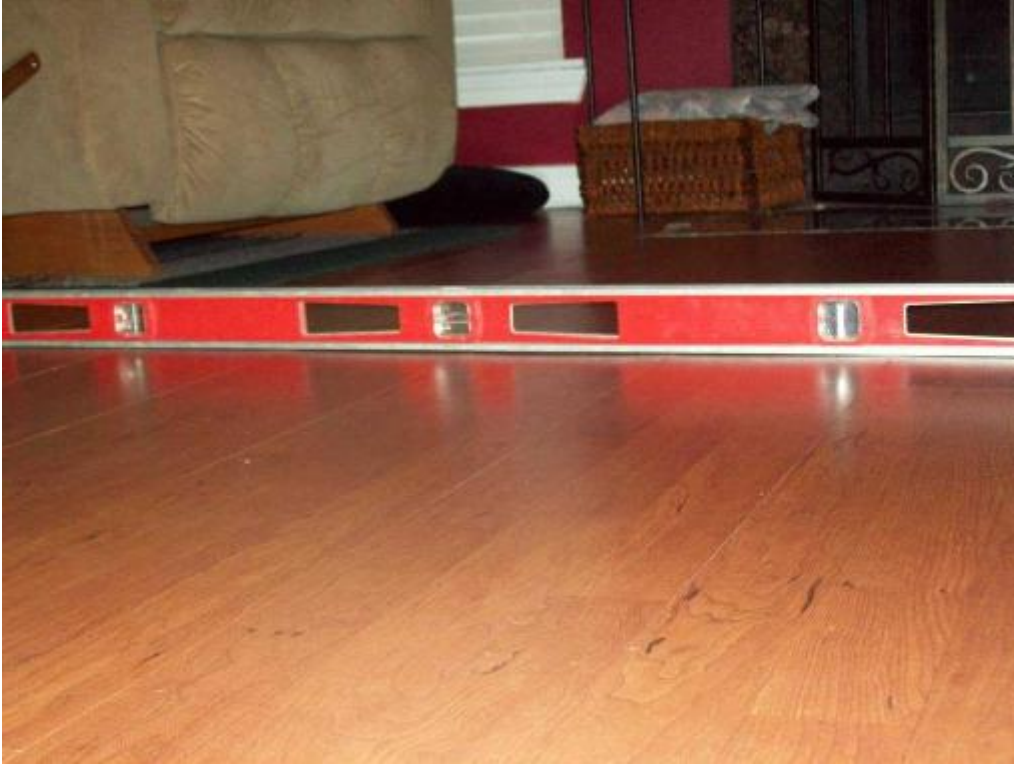
4 Den 7/1/2009
Taken By: Butch Bragg
Another area where water damage occurred.

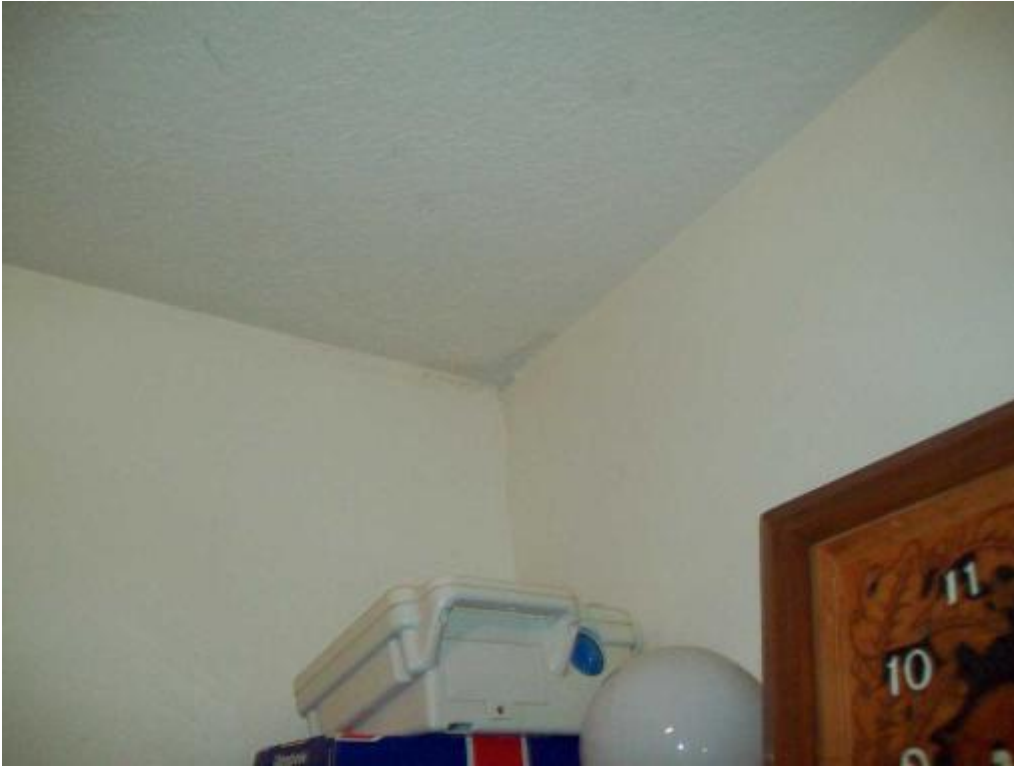
5 Closet

This room is directly at eh fireplace point of water entry.

Stain in corner of closet -- it is not clear in photo but all drywall in this area is directly behind the fireplace where the water entered from the blown off cap.

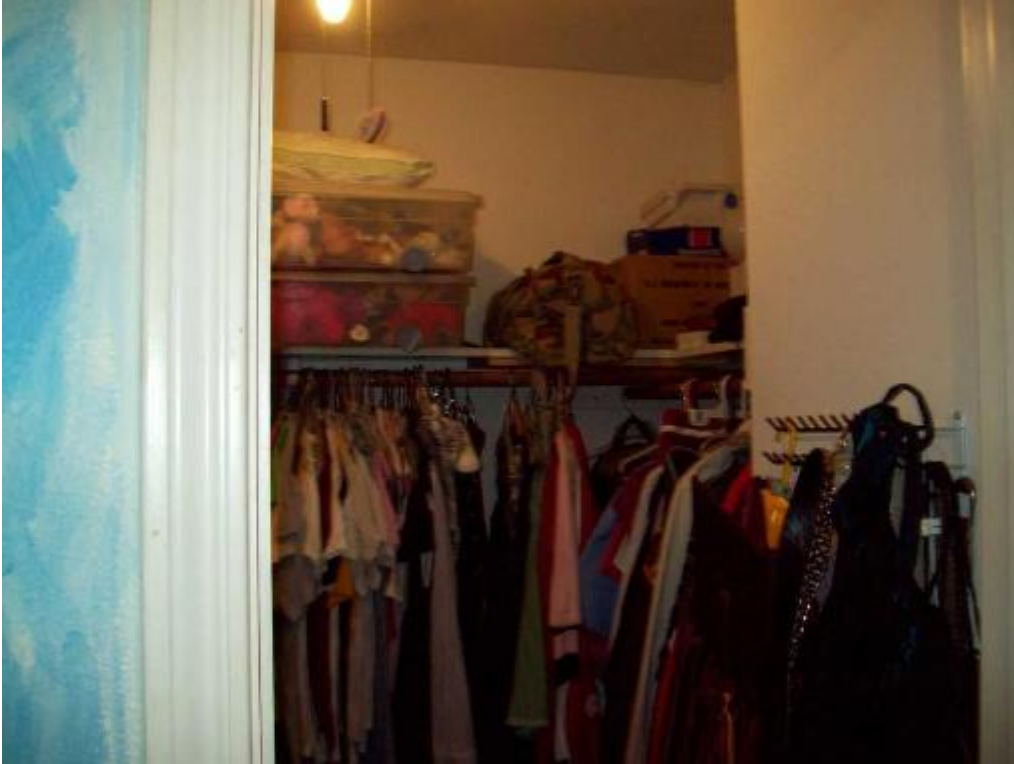
See photo for overview of contents in closet. Closet is full of contents to be removed.

6 Closet 7/1/2009
Taken By: Butch Bragg
Contents of closet

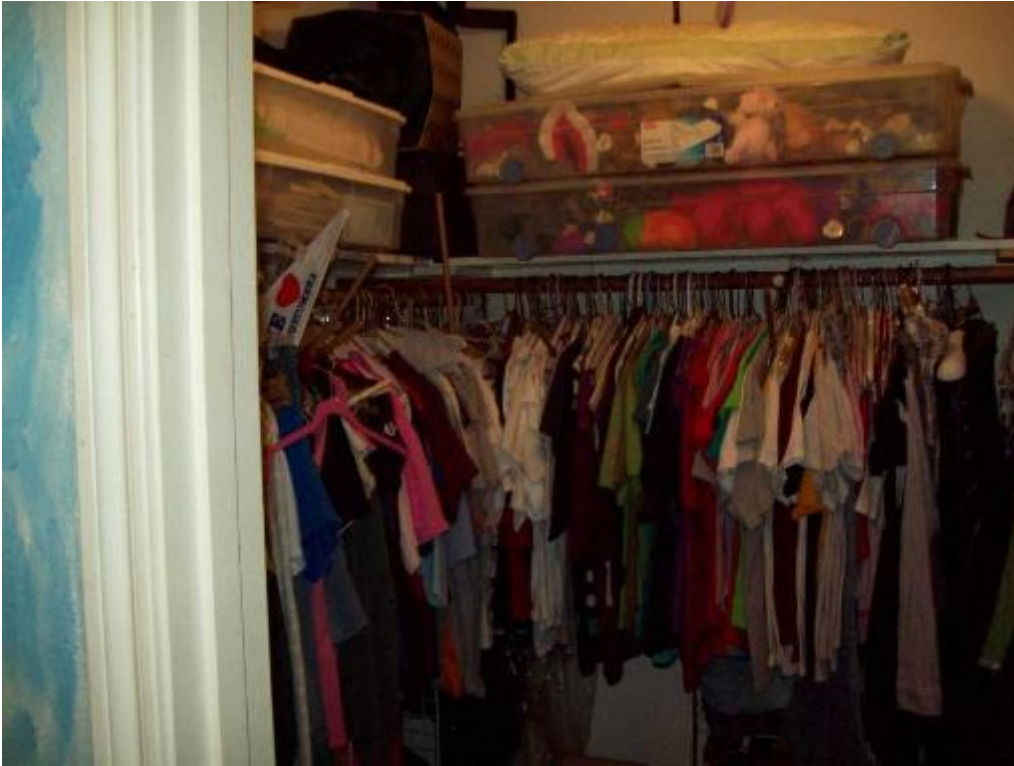
7 Closet 7/1/2009
Taken By: Butch Bragg
More contents in closet.

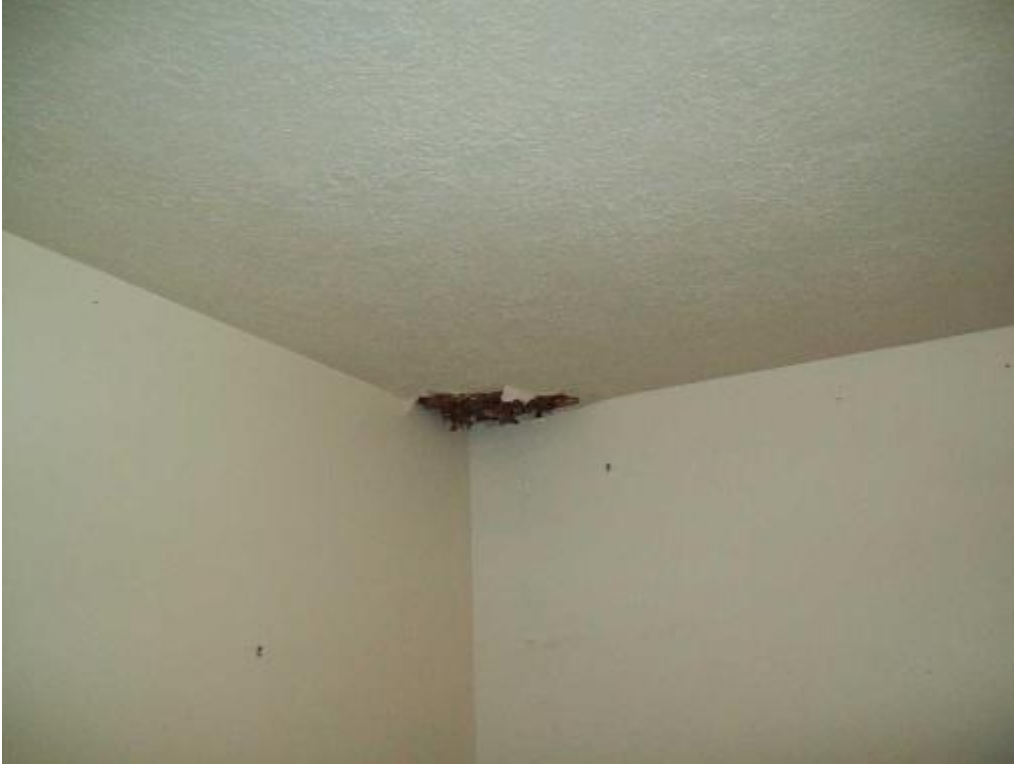
| DESCRIPTION | QUANTITY | UNIT COST | RCV | DEPREC. | ACV |
|---|---|---|---|---|---|
| WATER LEAKED DOWN WALL INTO CARPET & SUBFLOOR CAUSING IT TO SWELL. THE GAME ROOM IS FILLED WITH SPORTS MEMORABILIA WHICH WILL REQUIRE REMOVING, STORING & REHANGING TO FACILITATE THE REPAIRS. | | | | | |

- 8 Game room 7/1/2009
 Taken By: Butch Bragg
 One area where water drained through the ceiling damaging
 drywall and carpet.

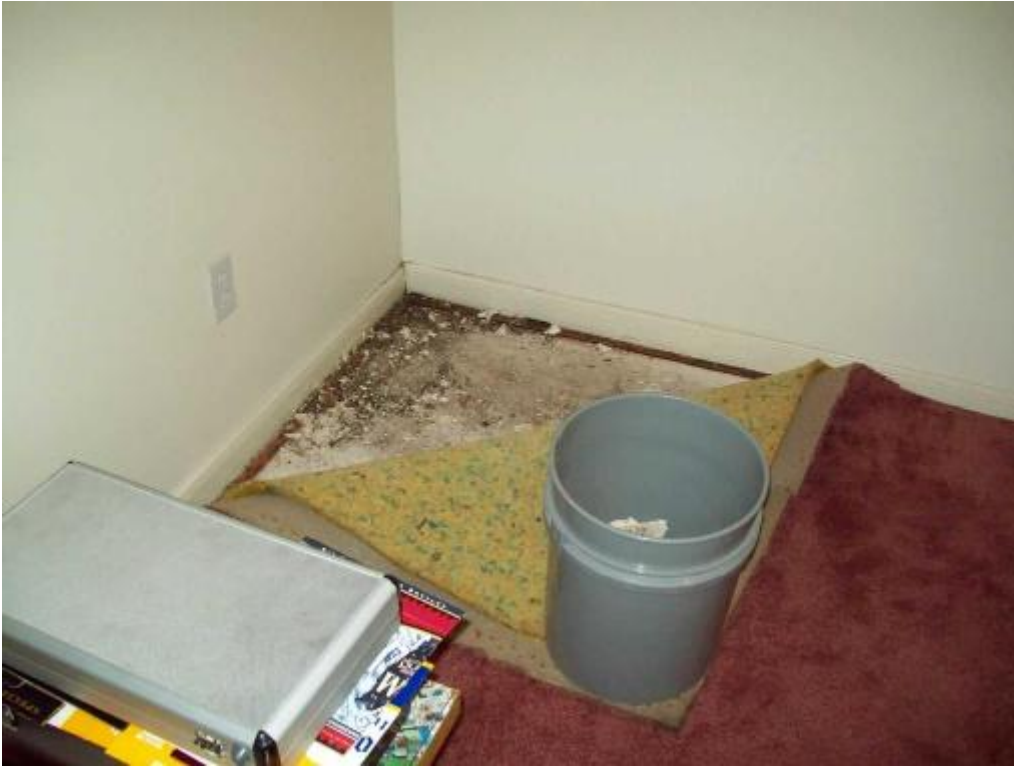
9 Game room 7/1/2009
 Taken By: Butch Bragg
 Main area where water entered -- closet backs up to this wall.

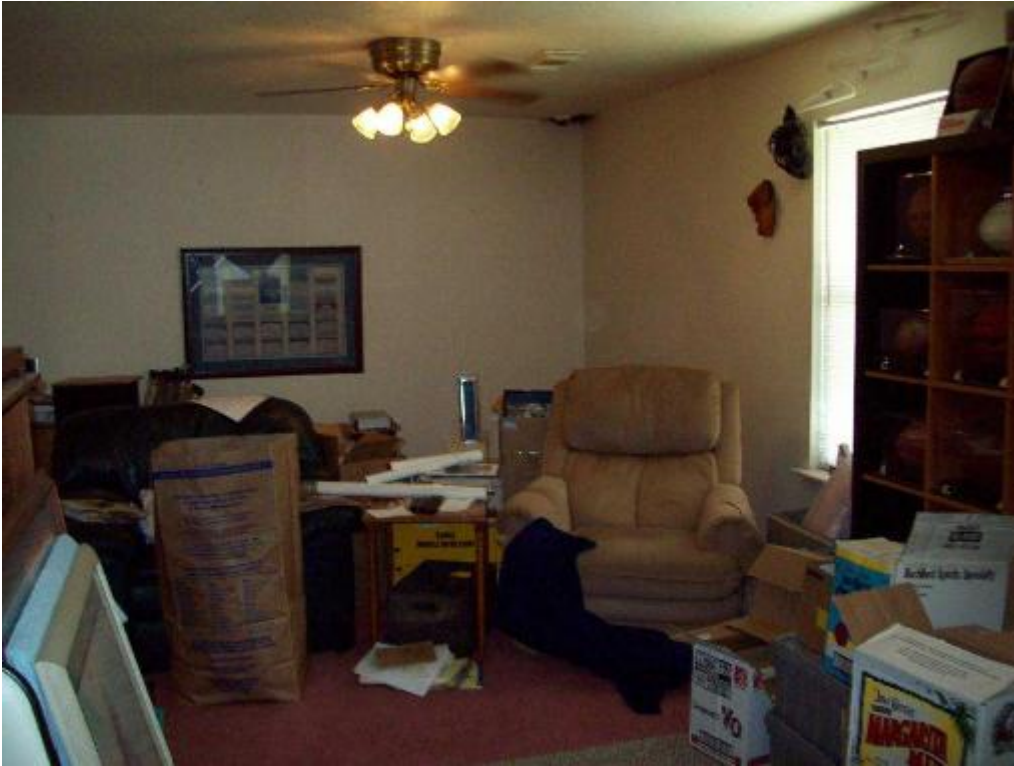
10 Game room 7/1/2009
 Taken By: Butch Bragg
 Contents and sports items

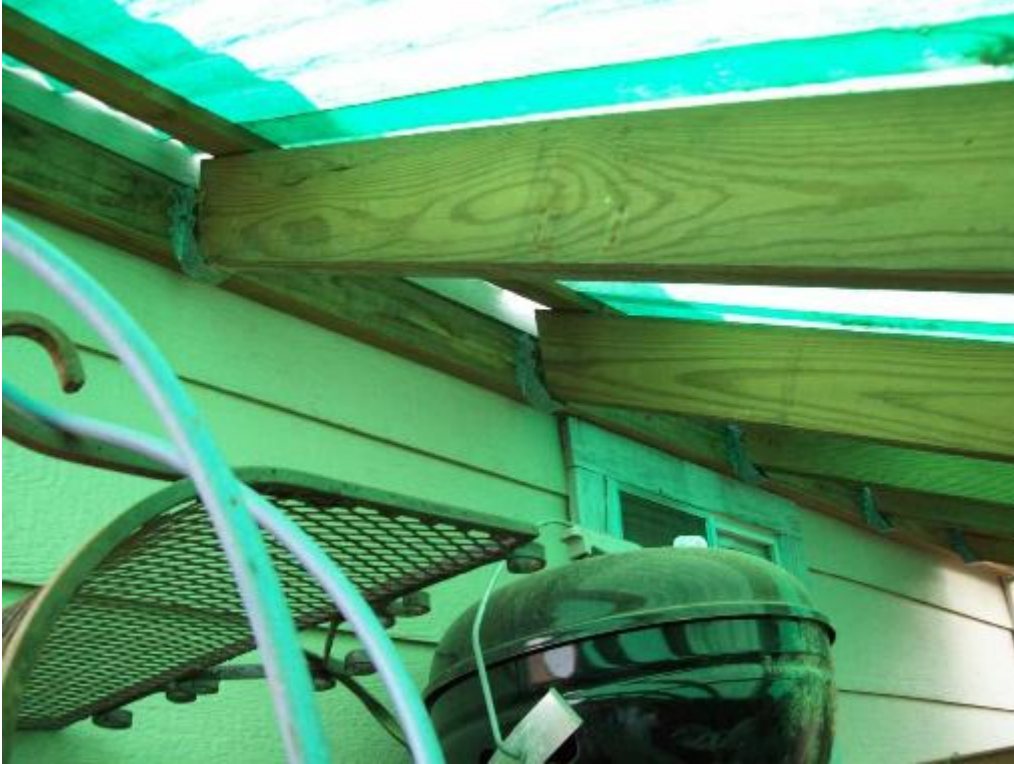
| DESCRIPTION | QUANTITY | UNIT COST | RCV | DEPREC. | ACV |
|--|---|---|---|---|---|
| THE GREENHOUSE SLOPED ROOF FRAMING WAS ATTACHED TO THE REAR ELEVATION OF THE SHED & TO THE REAR FENCE. THE HIGH WINDS CAUSED THE ROOF FRAMING TO BECOME DETACHED FROM ITS ANCHORS & COULD COLLAPSE WITHOUT NOTICE & HAS NOW CREATED A HEALTH HAZARD. THE ROOF REQUIRES COMPLETE DEMOLITION & REBUILDING. | | | | | |
| Greenhouse sheeting has been shifted when the frame moved and all the fasteners have shifted creating areas of damage around all fasteners. Frame members have been pulled from there saddles and allowed the racking of the entire framework. Labor to dis-assemble the entire cover and re-assemble with new sheeting is not cost effective compared to doing a demo on the entire unit and replacing it. | | | | | |

- 13 Greenhouse roof 7/1/2009
 Taken By: Butch Bragg
 Frame has been pulled from the saddles on most of the 2x6
 framing -- shifting roof and fasteners.

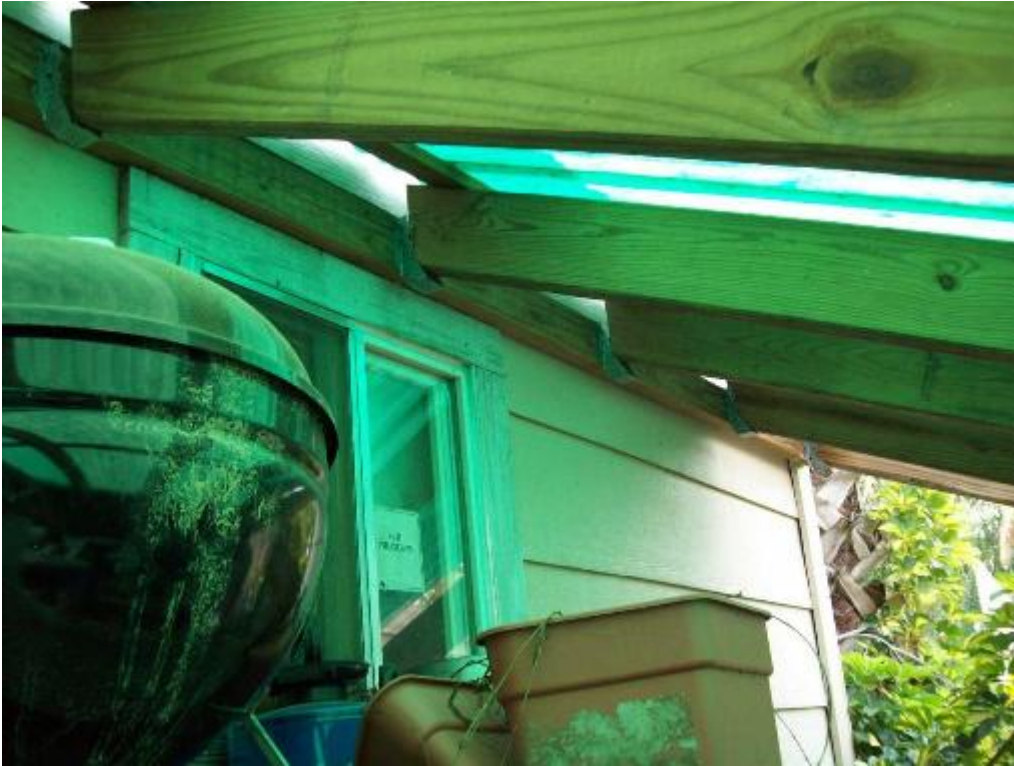
- 14 Greenhouse roof 7/1/2009
 Taken By: Butch Bragg
 More shifted 2x6 framing

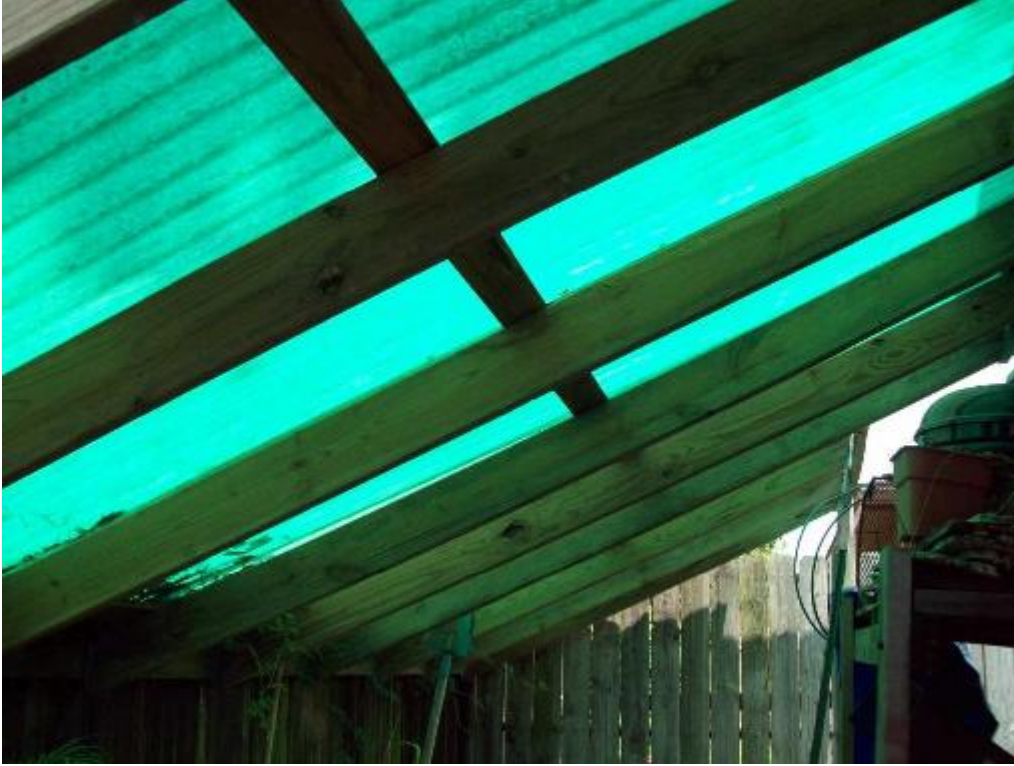
- 15 Greenhouse cover 7/1/2009
 Taken By: Butch Bragg
 Overview of shifted cover -- two panels are completely gone.
