A- Select Services

Insured: Sample Large Loss 3
Property:
PASADENA, TX 77505

Claim Number:	Policy Number:	Type of Loss: Hurricane	
Coverage		Deductible	Policy Limit
Dwelling		\$2,285.00	\$228,500.00
Other Structures		\$0.00	\$22,850.00

Price List:	TXHO5B_JAN09
	Restoration/Service/Remodel
Estimate:	SAMPLELARGELOSS3

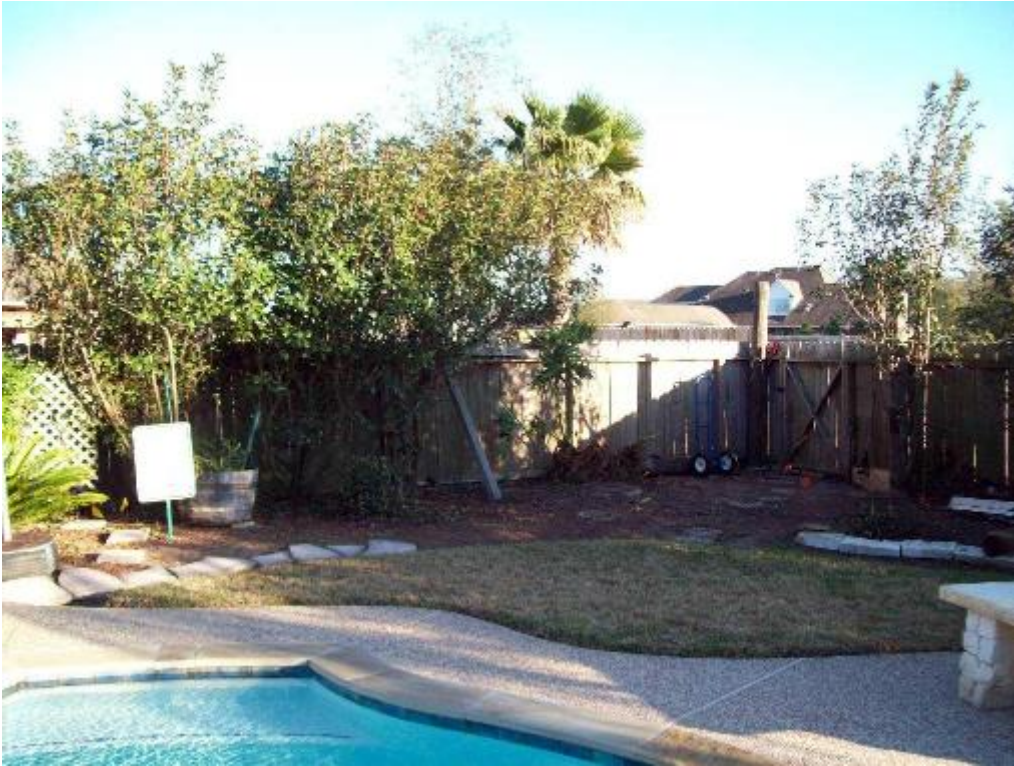
- 1 Fence damage 2/2/2009
Taken By: Butch Bragg
Additional fence discovered damaged when bushes were removed.

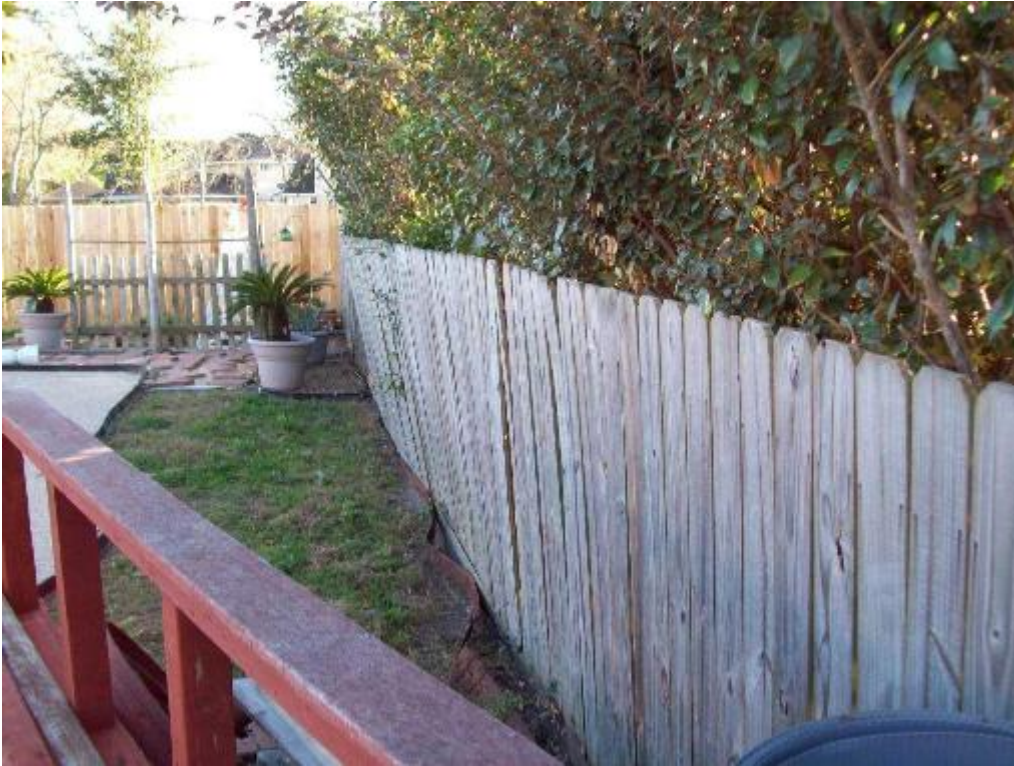
- 2 Damaged fence 2/2/2009
 Taken By: Butch Bragg
 View from neighbors yard showing newly discovered area of
 fence damage.

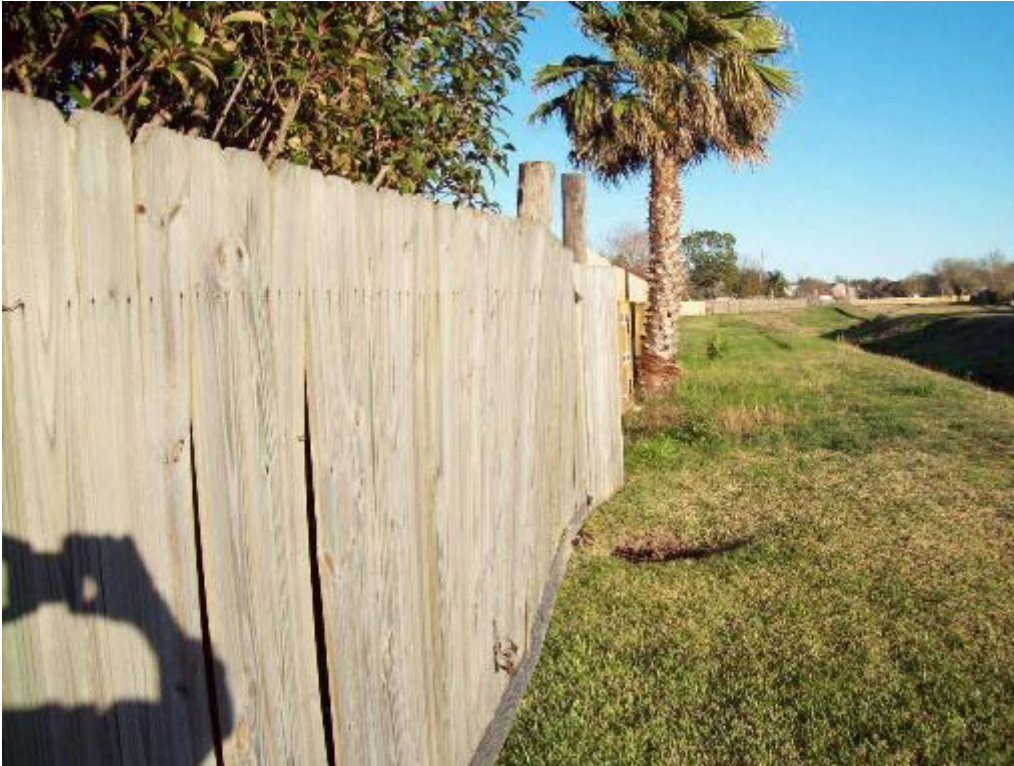
- 3 Damaged rear fence 2/2/2009
Taken By: Butch Bragg
Additional fence discovered to have broken posts at rear of lot.

DESCRIPTION	QUANTITY	UNIT COST	RCV	DEPREC.	ACV
LEFT REAR FENCE					
68. R&R Wood fence 5'- 6' high - treated	88.00 LF	29.07	2,558.16	(0.00)	2,558.16
42. Haul debris - per pickup truck load - including dump fees	3.00 EA	106.20	318.60	(0.00)	318.60
43. General clean - up	2.00 HR	28.98	57.96	(0.00)	57.96
Totals: FENCING			5,060.52	0.00	5,060.52
Total: OTHER STRUCTURES			16,829.20	0.00	16,829.20
Line Item Totals: SAMPLELARGELOSS3			26,275.70	0.00	26,275.70

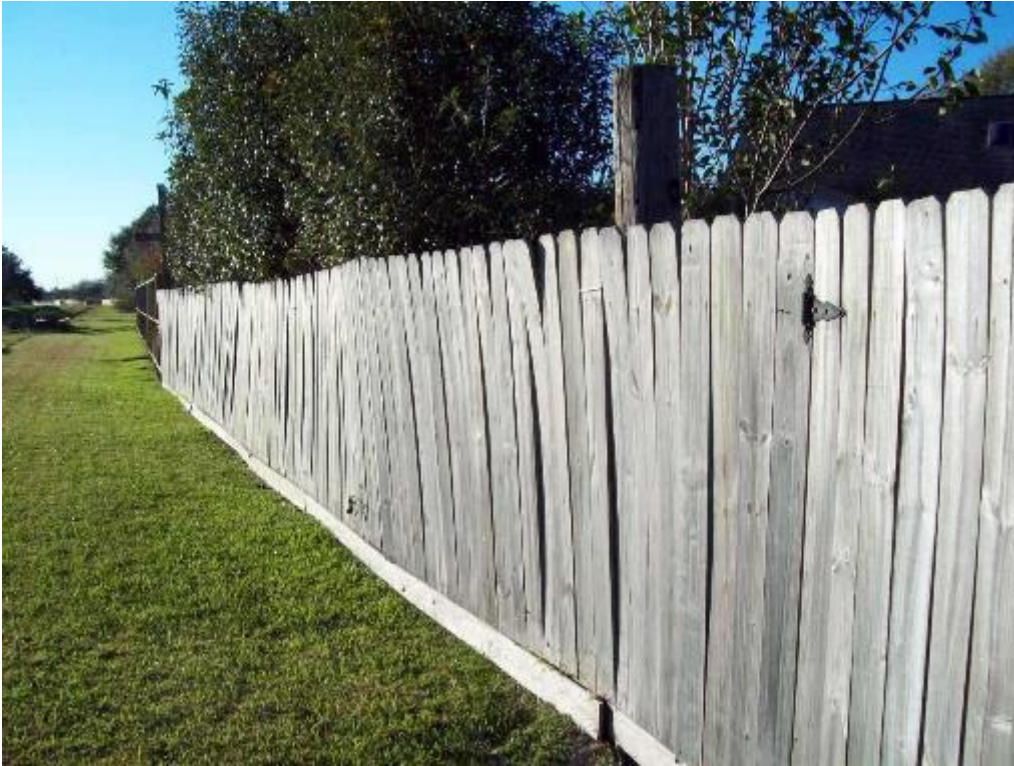
- 4 Rear view 2/2/2009
 Taken By: Butch Bragg
 Damaged fence at rear of lot from opposite direction.

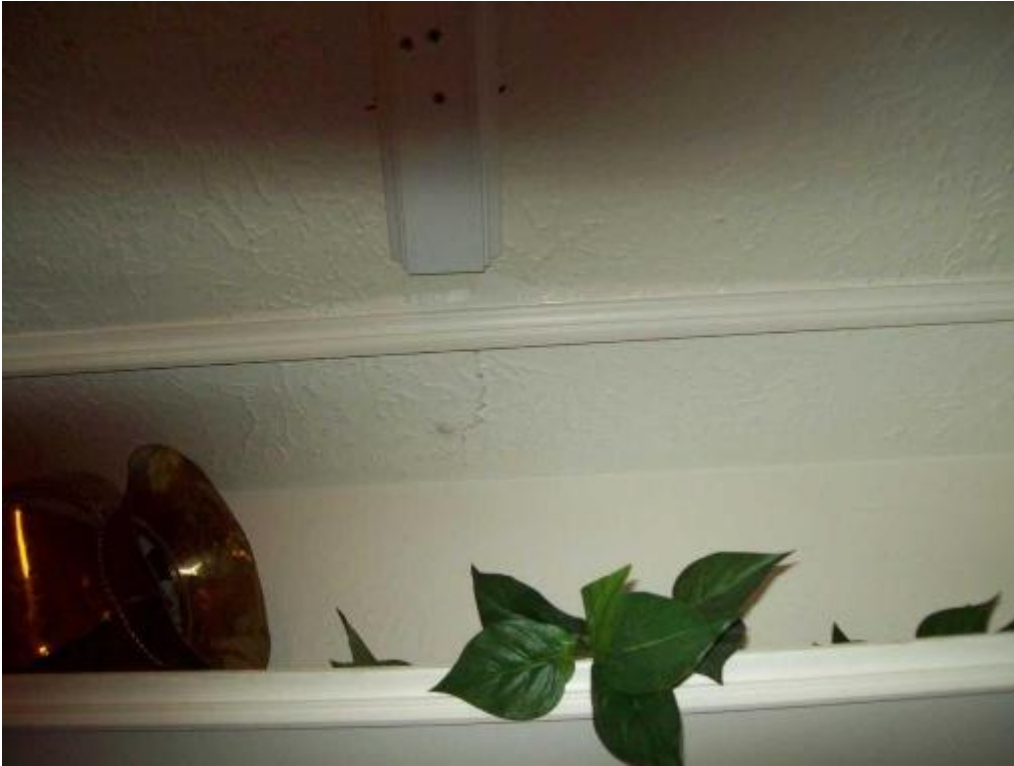
DESCRIPTION	QUANTITY	UNIT COST	RCV	DEPREC.	ACV
RT SIDE 2ND FLOOR BEDROOM - WET DRYWALL CEILING - DAMAGE TO TEXTURE, INSULATION, WOOD TRIM (CROWN), SHELVING --- WATER ENTRY APPEARS TO HAVE BEEN FROM THE POINT OF WHERE THE WALL MET THE CEILING IN THE AREA OF THE ROOF REPAIR.

- 5 water damage at wall 2/8/2009
 Taken By: Butch Bragg
 Area where damaged ceiling meets the wall and water damaged
 side wall -- not on orig. estimate.

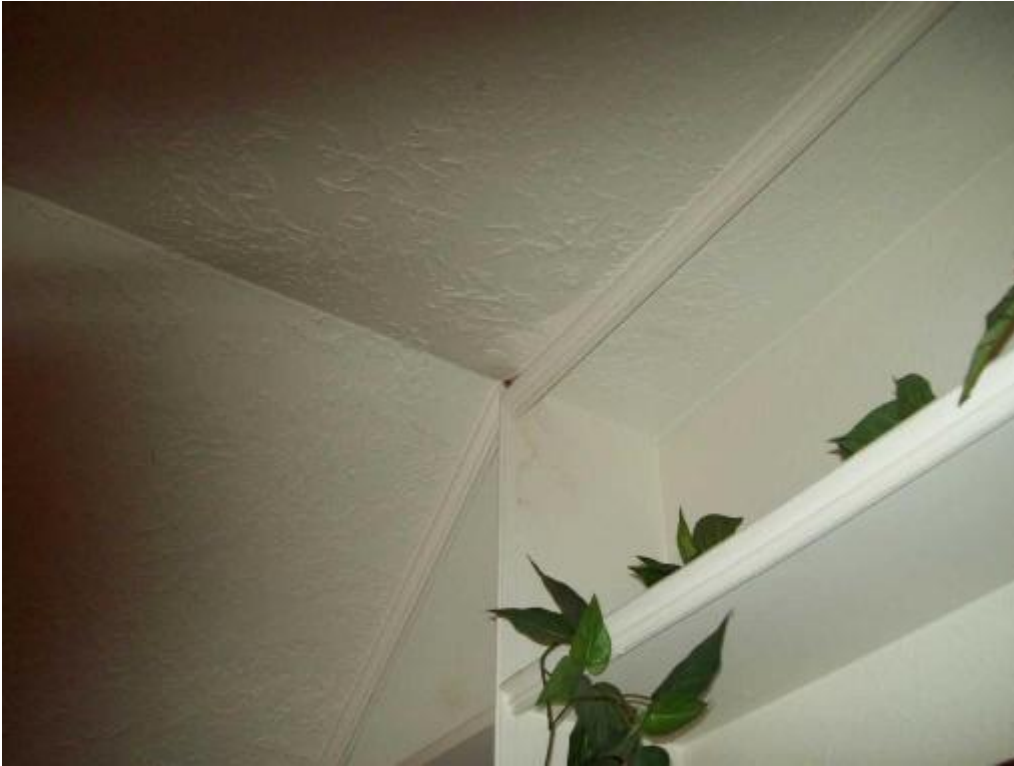
- 6 Water damaged 2/8/2009
 Taken By: Butch Bragg
 Another area where water entered from ceiling damaging wall
 area.

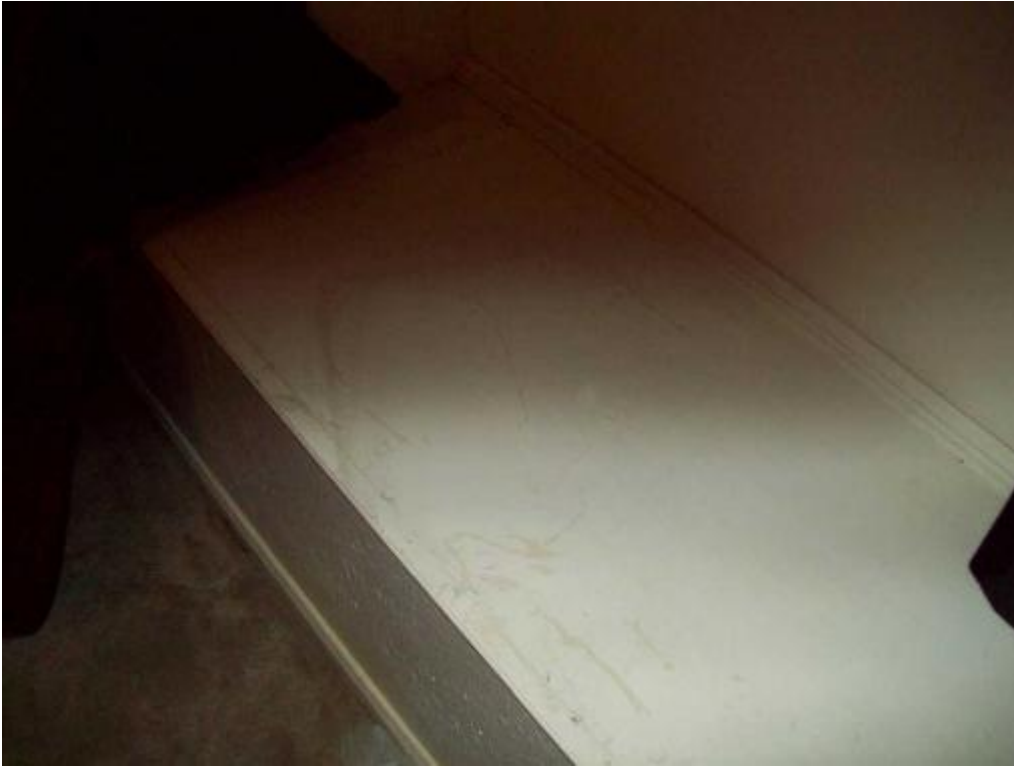
- 7 Damaged wood 2/8/2009
 Taken By: Butch Bragg
 Wood window seat where water ran down from ceiling leak and
 was hidden under contents.

44. R&R Window stool & apron	5.00 LF	6.36	31.80	(0.00)	31.80
45. Seal & paint window sill	5.00 LF	1.93	9.65	(0.00)	9.65
46. Paint baseboard - one coat	76.00 LF	0.72	54.72	(0.00)	54.72

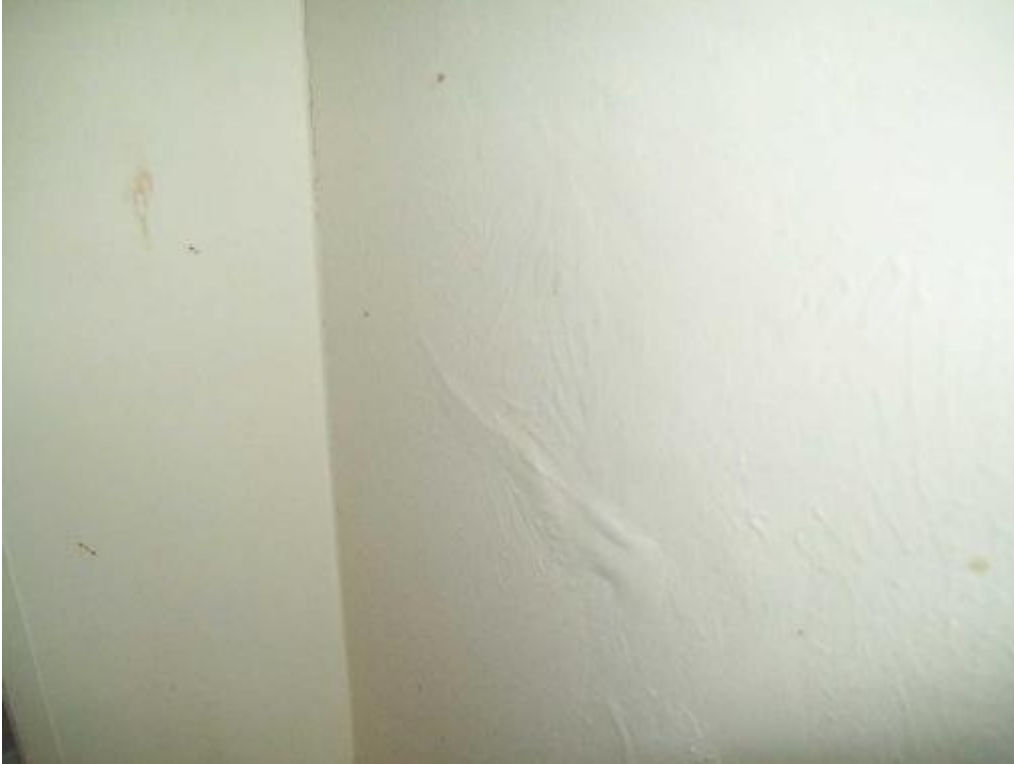
- 8 Blistered paint 2/8/2009
Taken By: Butch Bragg
Wall area directly under leak from ceiling.

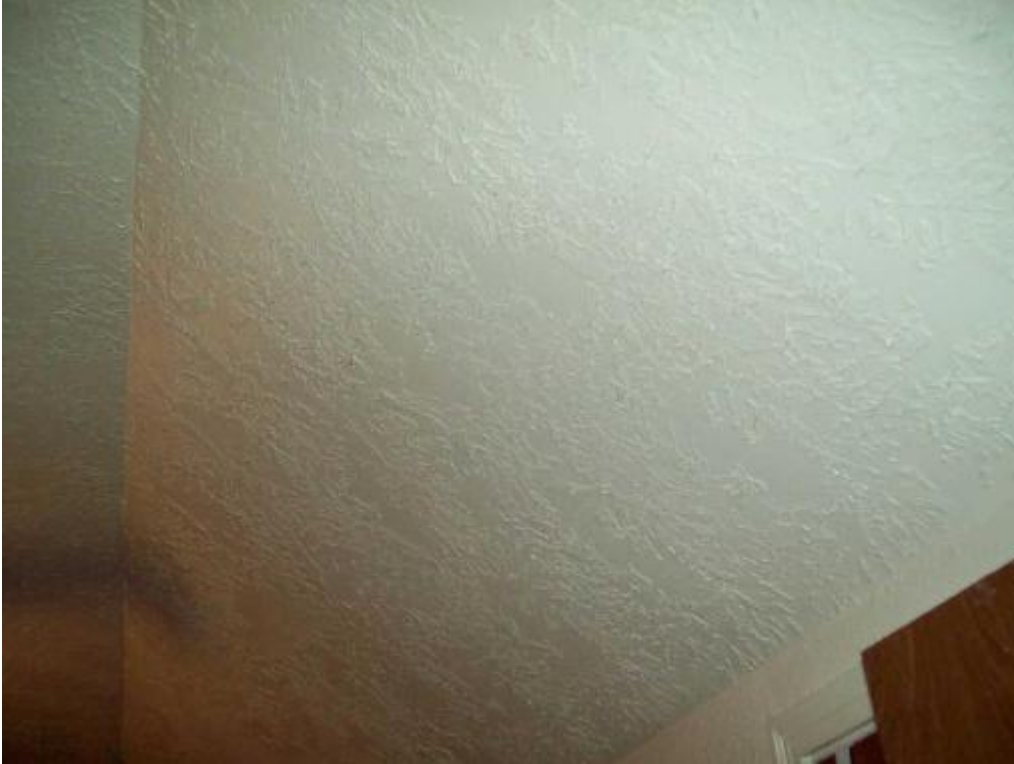
9 Texture 2/8/2009
 Taken By: Butch Bragg
 Texture in this room is heavy hand applied.

DESCRIPTION	QUANTITY	UNIT COST	RCV	DEPREC.	ACV
3. R&R 1/2" drywall - hung, taped, ready for texture	96.00 SF	1.64	157.44	(0.00)	157.44
4. Texture drywall - heavy hand texture	399.39 SF	0.65	259.60	(0.00)	259.60

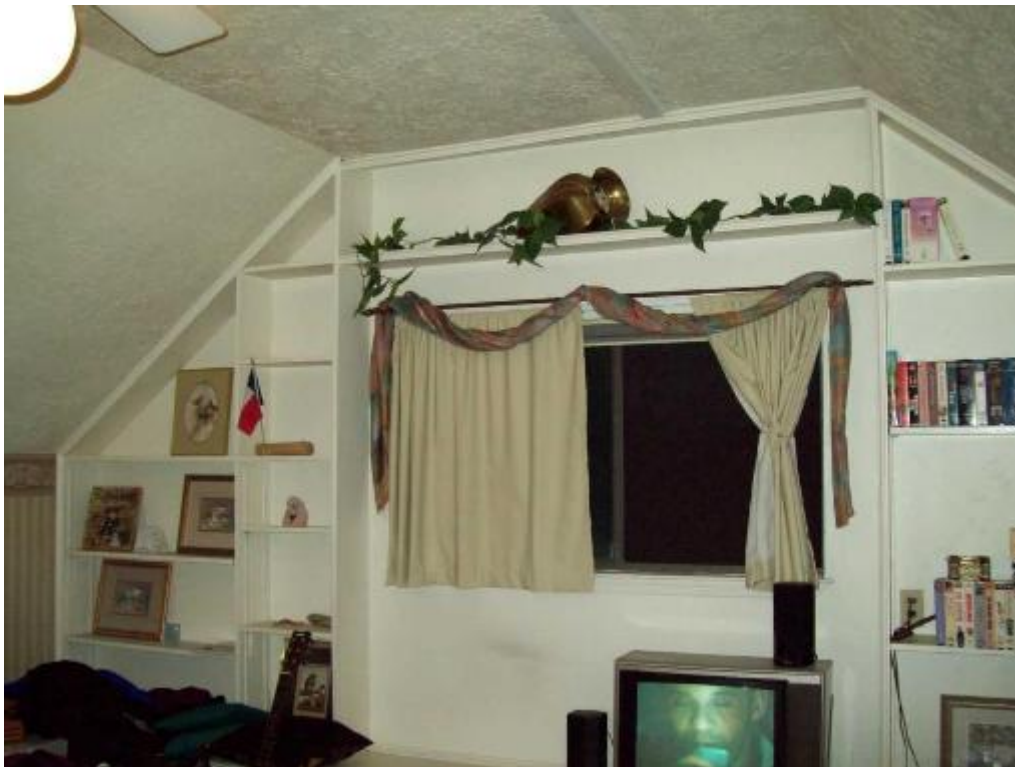
10 End wall 2/8/2009

Area where water damaged drywall and wood surfaces. Note 1x4 on ceiling covering crack where water ran over to the wall. Crack in ceiling is directly under the end of this board.

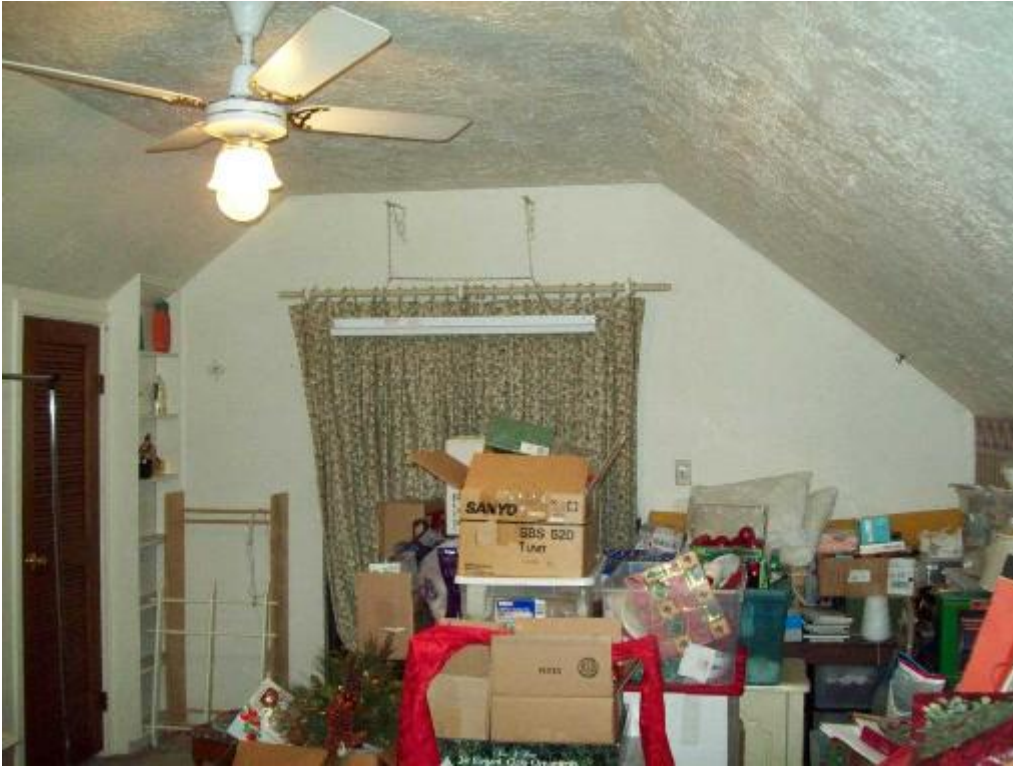
11 Upstairs bedroom N 2/8/2009

Bedroom on north end of upstairs where door is being replaced.
There was nothing allowed for the repairs and painting that will be
necc. after replacement.

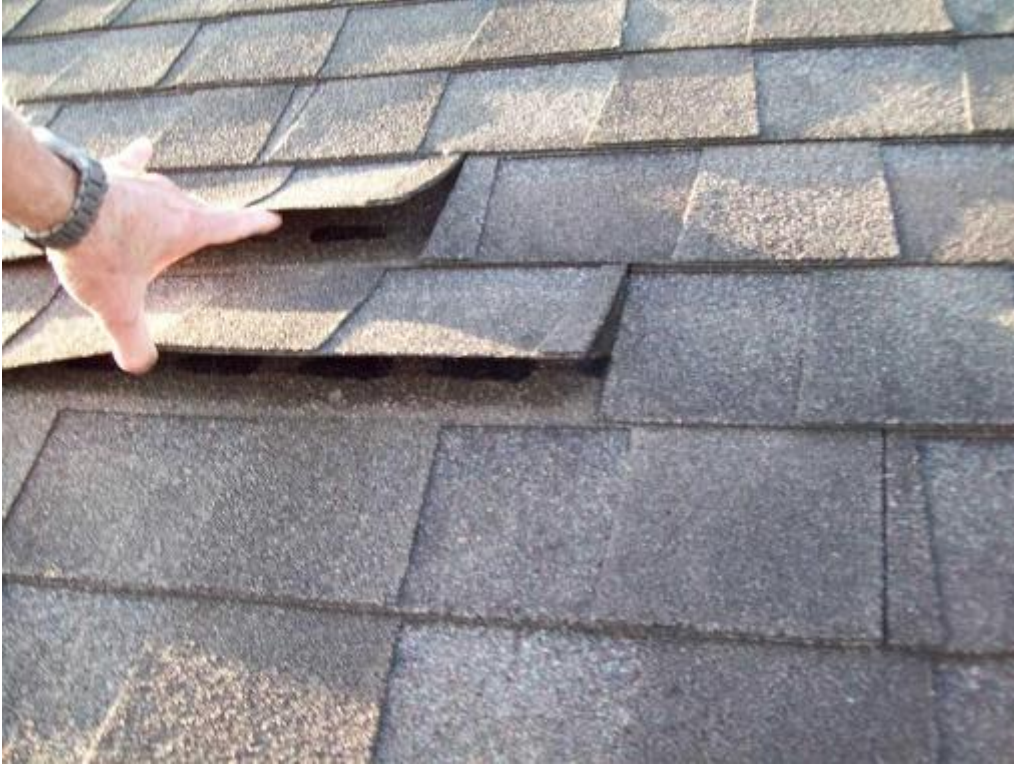
12 East slope roof 2 2/23/2009

As per the homeowner, adjuster stated that the estimate would include a minimum roof repair but this item was left off of the original estimate. The minimum charge was to repair a small area over the water damaged interior repairs listed by original adjuster. Photos are attached of this area but I did not want to disturb the area as it is no longer leaking but it appears there could be some shingles in need of removal and re-nailing.

This is a 10/12 -- 2 story roof. This is in the area where the water entered. Tabs are not re-sealed and it appears that some nails may be pulled through the actual shingle.

DESCRIPTION	QUANTITY	UNIT COST	RCV	DEPREC.	ACV
ATRIUM ROOF					
1. Reglaze 3/8" plexiglass - single glazed	32.00 SF	29.28	936.96	(0.00)	936.96
2. Install 3/8" plexiglass roof panel	80.00 SF	16.18	1,294.40	(0.00)	1,294.40
72. Roofing repair - Minimum charge	1.00 EA	485.00	485.00	(0.00)	485.00

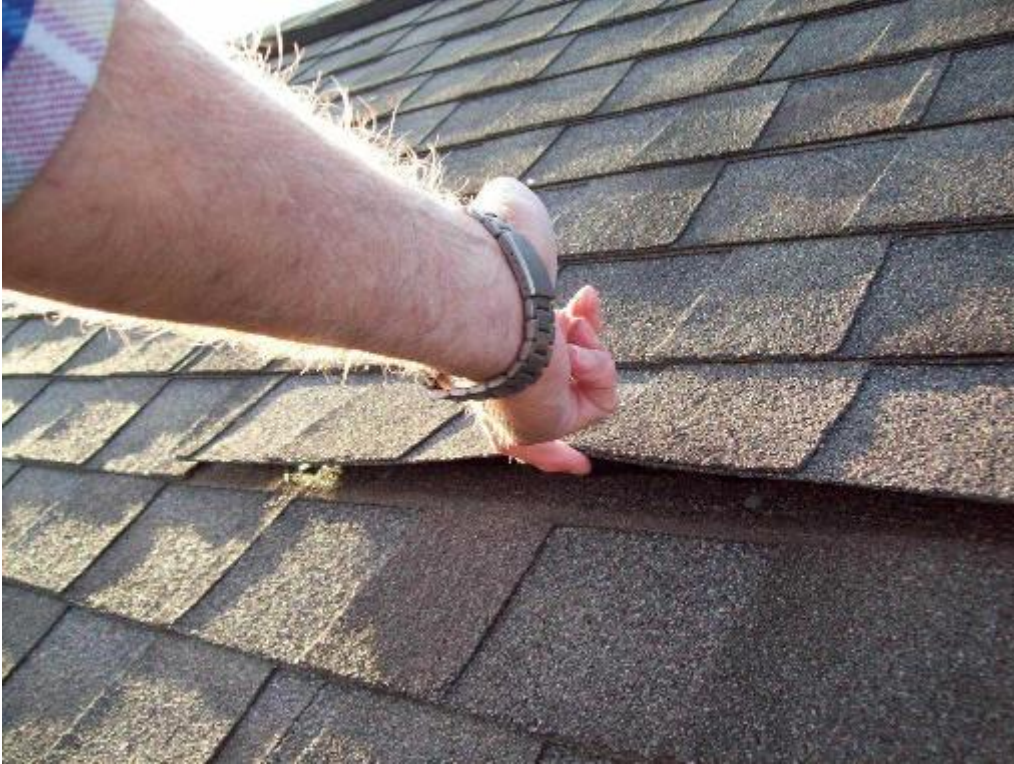
13 East Slope roof 2/23/2009

This is a 10/12 -- 2 story roof. This is in the area where the water entered. Tabs are not re-sealed and it appears that some nails may be pulled through the actual shingle.
