A- Select Services

Insured: Sample file 1
Property: Any Street
PASADENA, TX 77505

| Claim Number: | Policy Number: | Type of Loss: Wind Damage | |

Price List: TXHO5B_MAY09
Restoration/Service/Remodel
Estimate: SAMPLEFILE1

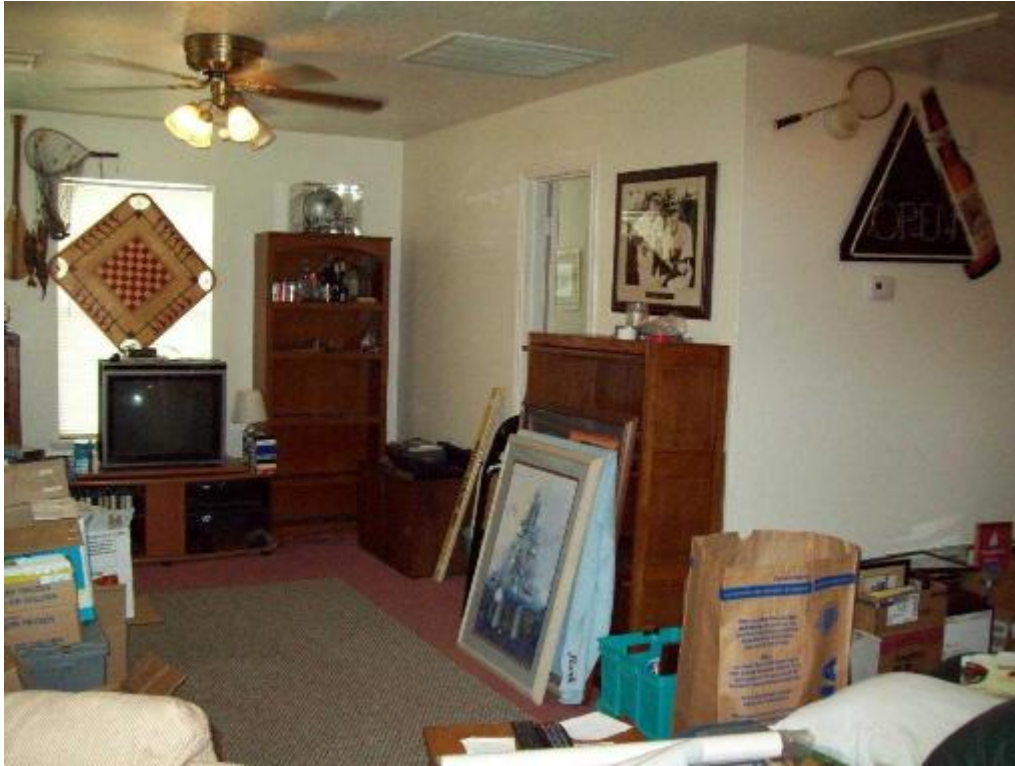
12 Game room 7/1/2009

| DESCRIPTION | QUANTITY | UNIT COST | RCV | DEPREC. | ACV |
|---|---|---|---|---|---|
| WATER LEAKED DOWN WALL INTO CARPET & SUBFLOOR CAUSING IT TO SWELL. THE GAME ROOM IS FILLED WITH SPORTS MEMORABILIA WHICH WILL REQUIRE REMOVING, STORING & REHANGING TO FACILITATE THE REPAIRS. | | | | | |
